Aircraft Accident Investigation Report

Aircraft Fire on Ground
Ethiopian Airlines, Flight ET3739
Boeing 777F, Registration ET-ARH
Pudong International Airport
Shanghai, P.R. China
July 22, 2020

Report No. 20200722YDSQ01
Aviation Safety Committee
Eastern Regional Administration of Civil Aviation Administration of China
December 30, 2021

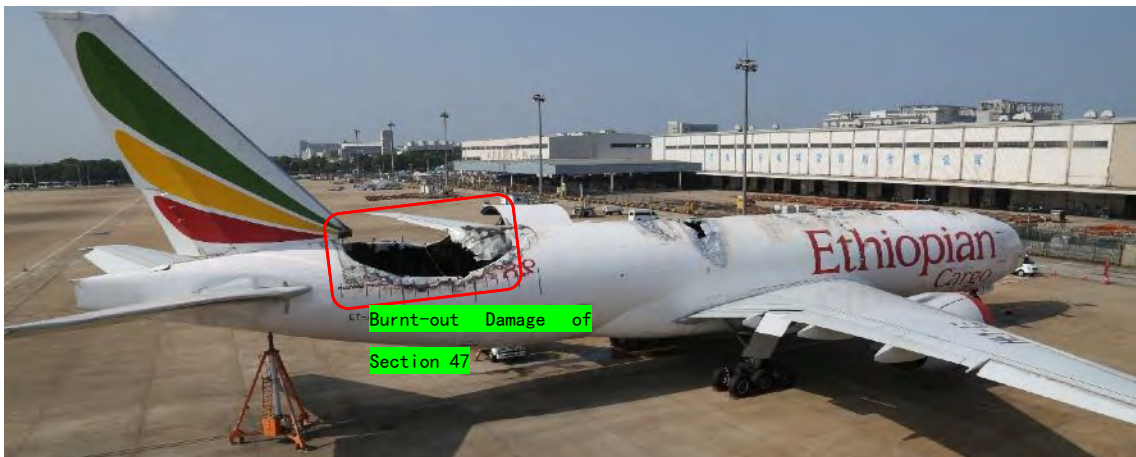
Figure 3 Damage to Upper Fuselage

The skin, main structural components such as frames and stringers of the upper fuselage from section 41 to 48 were damaged by the fire (Figure 2). Multiple burn-through areas were presented in the crown centerline, of which the most severe area was section 47 (Figure 3) (STA1832-STA2150). The skin, frames and stringers above stringers S24L and S24R were burnt out. There were two large, ablated skin areas above the bulk cargo door of the right fuselage between stringer S24R and S27R (Figure 4). The remaining fuselage structures sustained extensive thermal damage and sooted. The dorsal fin skin and structures of the vertical stabilizer were burnt out (Figure 5). The radial stiffeners, doubler and frame chords of the aft pressure bulkhead were mostly burnt out (Figure 6).

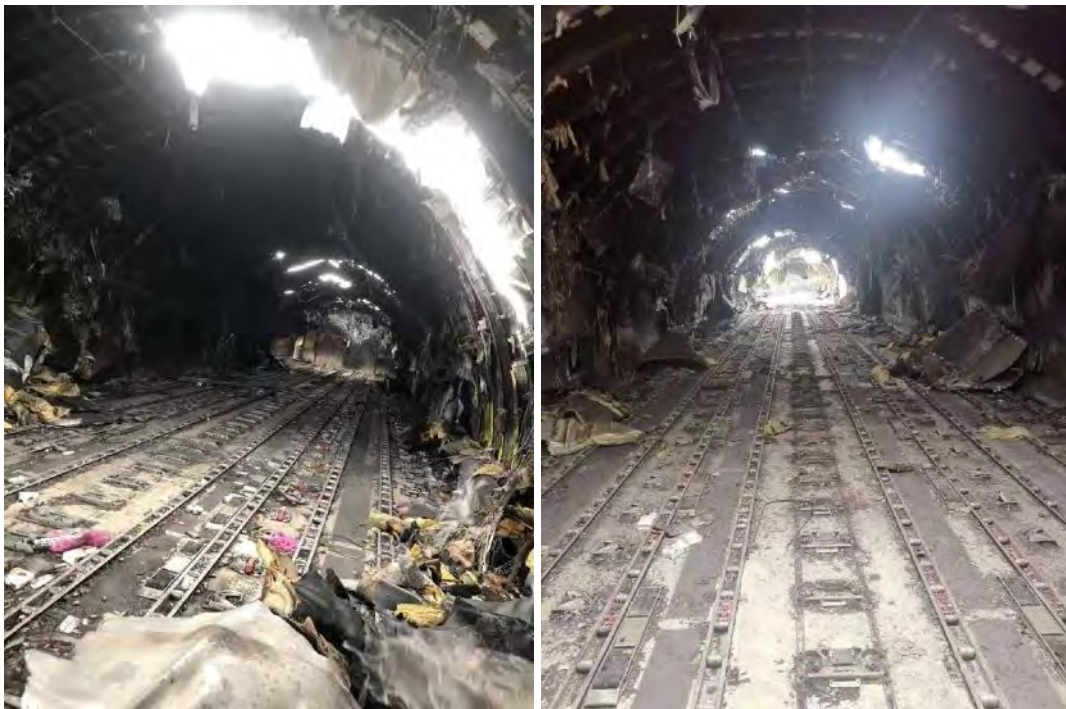
Figure 7 Interior of the Main Deck Cargo Compartment (Front and Rear View)

Components installed on the top of the main deck cargo compartment such as the ceiling panels, heat insulation cotton, smoke/fire detectors, light assemblies, sidewall panels, air condition ducts, wiring harness (including APU main feeder cables), wire mounting brackets, electrical plugs were burnt out (Figure 7). The interior linings of the main deck cargo compartment door were extensively burnt down, and the door structure was severely heated, which was stuck in the open position and could not be manually closed (Figure 8). The main deck cargo compartment floor in front of the aft pressure bulkhead was burnt through (Figure 9). The rigid cargo barrier in the main deck cargo compartment also sustained extensive thermal damage (Figure 10).

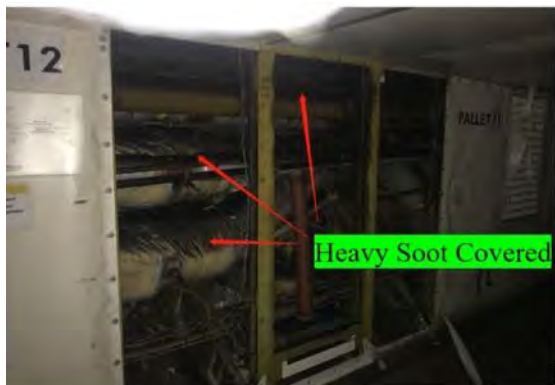
Figure 11 Inside the Lower Hold Side Wall

The structures of the forward and aft lower holds in the lower lobe were intact. After removing the side wall panels of the forward lower hold, the structures, ducts and equipment were obviously sooted (Figure 11). Most of the electronic equipment in the E/E bay were also sooted (Figure 12). The APU compartment was intact and no trace of fire or soot.

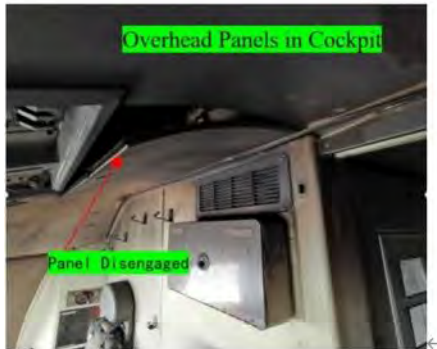
Figure 13 Panel Disengaged in the Cockpit

The overhead panels in the cockpit and supernumerary area were disengaged due to overheating (Figure 13 and 14). The internal furnishings, linings and components were sooted.

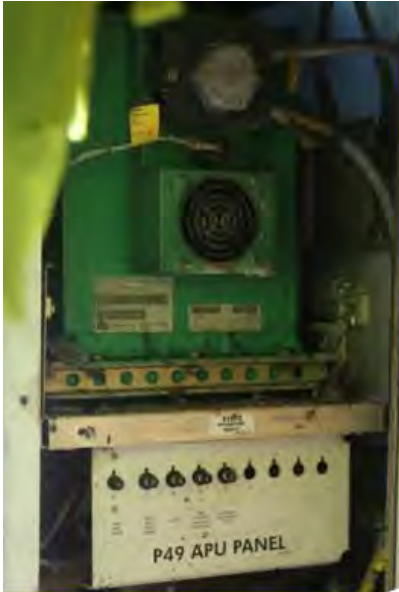
Figure 21 APU Battery

The ceiling of the bulk cargo compartment was burned through, the APU battery without trace of fire damage (Figure 21 and 22).

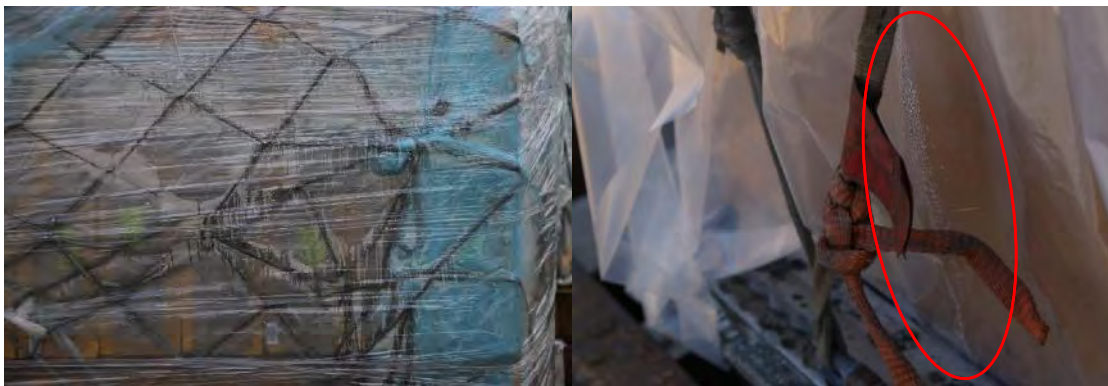
Figure 44 Condensation in the plastic film

It was possible that chlorine dioxide disinfection tablets of the goods were exposed to high temperature and humid environment. (Figure 43 and 44).

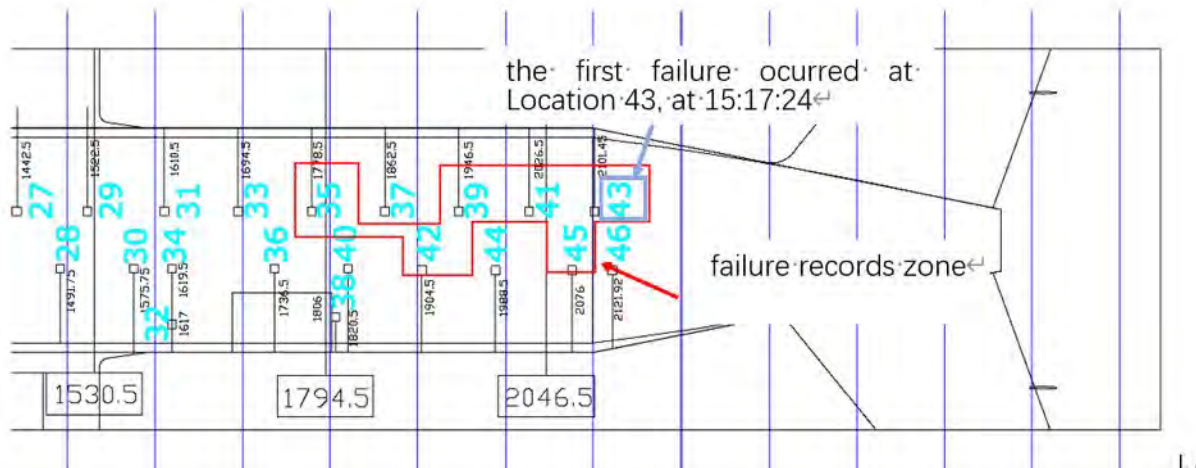
Figure 45 Locations of Failed Smoke Detectors

The above fault records show that the detectors located in the rear zones 6, 7 and 8 of the aircraft (stations STA1778.5 to STA2122) (Figure 45) failed first, and a detector overheat failure is triggered when the smoke detector recognizes a temperature either significantly less than -50°C or greater than about $+225^{\circ}\text{C}$. There were 15 detector failure records, of which 13 were from the right side, accounting for 87%. All failed detectors were located at the right side of the rear main deck cargo compartment. In addition, since NVM only recorded the failure of smoke detector function, and did not record the information of smoke warning, therefore, the first time when the fault information occurred was 15:17:24, which was later than the time of 15:14:04 when the crew reported fire warning.

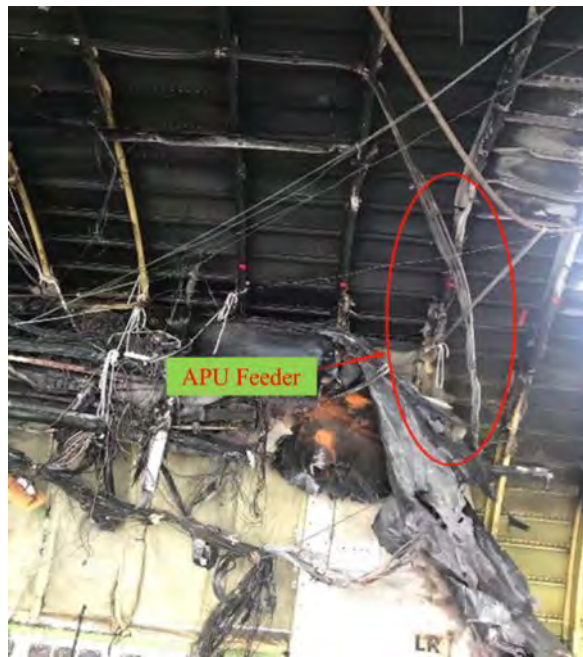
Figure 46 APU Feeder

The investigation team sent 7 wires (Table 5) from different fused parts of APU feeder (see Figure 46) to Tianjin Fire Material Evidence Identification Center of Fire Bureau of Ministry of Emergency Management for testing. In accordance with GB/T 16840.1-2008 (Technical Determination Method for Electrical Fire Evidence Part 1: Macroscopic Method), GB/T 16840.4-1997 (Technical Determination Methods for Electrical Fire Cause Part 4: Metallographic Method), GB/T 19267.6-2008 (Physical and Chemical Examination of Trace Evidence on Forensic Sciences Part 6: Scanning Electron Microscope/X Ray Energy Dispersive Spectrometry), the laboratory conducted the appraisal and analysis of the wires received for testing. All 7 wires were aluminum wires identified by macroscopic inspection, and the melted marks were extracted. The microstructure characteristics of the melted marks were analyzed through metallographic method. Surfaces between the melted marks, melted beads and the wires had no transition zone characteristic, and the microstructure of the melted marks is all equiaxed grain. Then the laboratory submitted the Material Evidences Analysis and Identification Report on Accident of Ethiopian Airlines B777F Aircraft (Appendix 6). The conclusion of the test was that, all the melted marks on 7 wires were the melted marks due to fire burning.

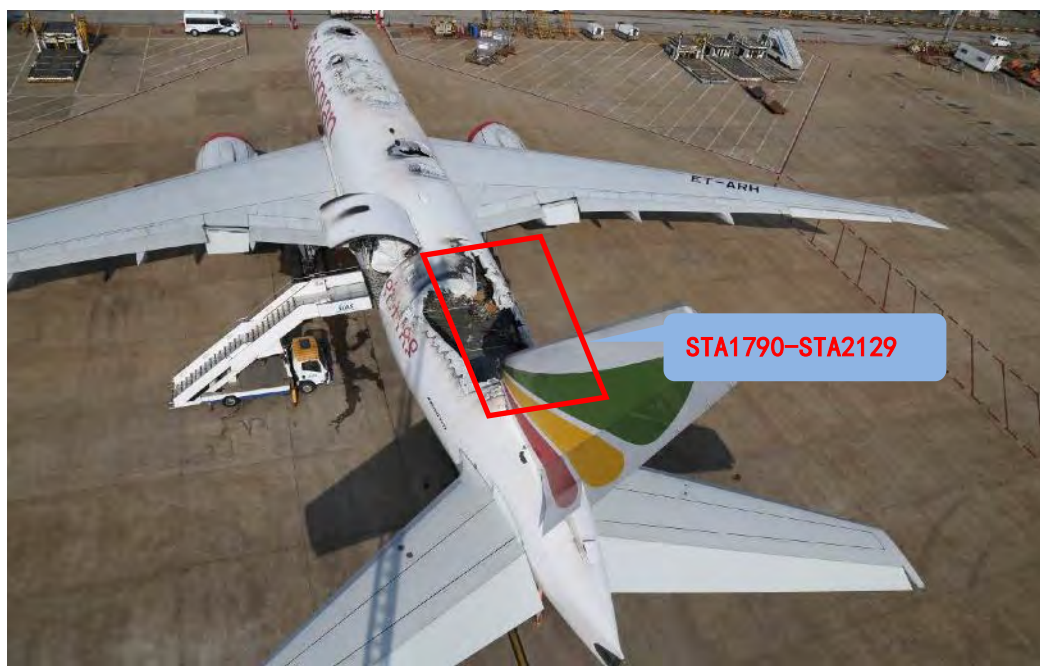
Figure 60 the Largest Burn-through Area of Aircraft Skin

c) There were multiple burn-through areas in the crown centerline of the fuselage skin, among which the largest area was located between STA1790 to STA2129 (Figure 60).

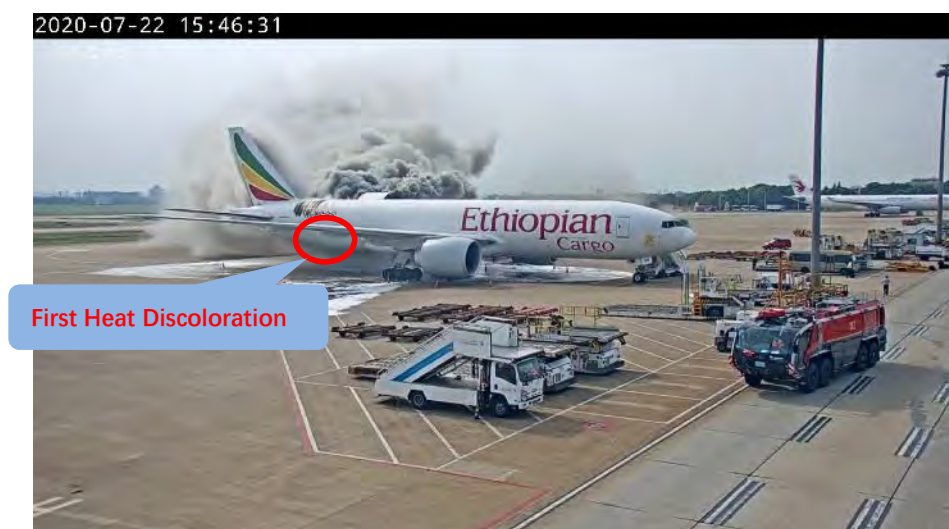
Figure 61 Screenshot of CCTV Footage of Parking Position No. 307

d) The CCTV footage of parking position No. 307 showed that the heat discoloration firstly happened to the skin of the aft area of main deck cargo compartment, while the rest part of the compartment skin did not discolor at that time (Figure 61).

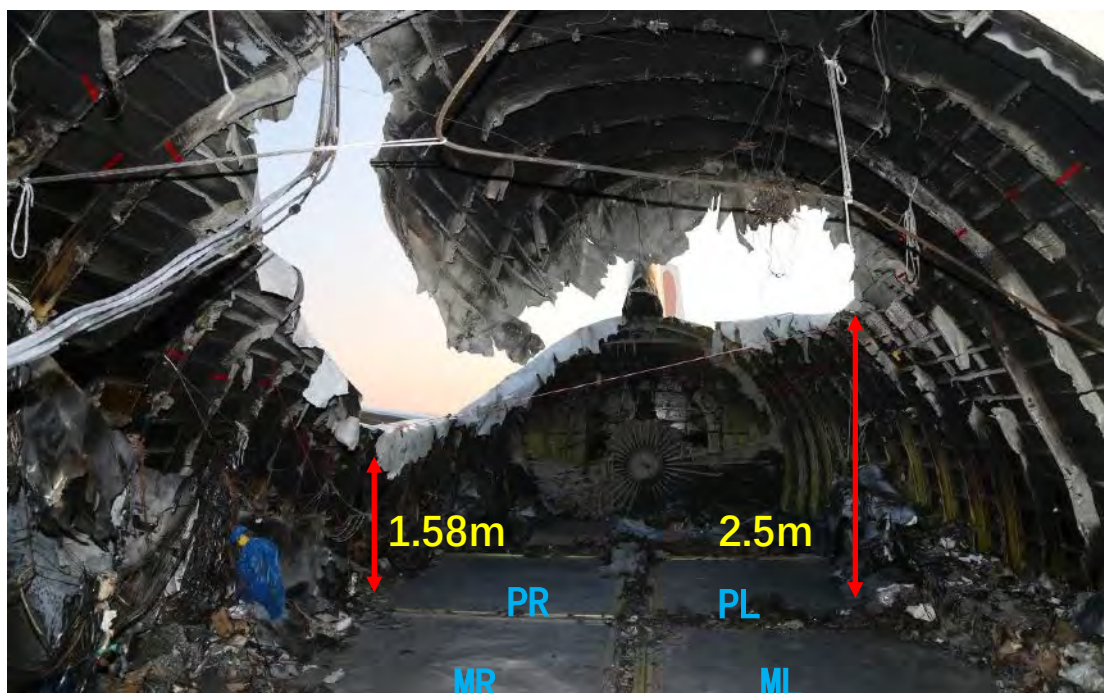
Figure 62 Fuselage Damage Between STA1937 and STA1958

a) the aircraft fuselage skin and the structure between STA1937 and STA1958 in the initial area of fire sustained the most severe fire damage, and the right side of which was more severe than that of the left side. The left remaining skin of fuselage between STA1937 and STA1958 was higher than the right side, with the height of 2.5m on the left and 1.58m on the right from the main deck cargo compartment floor (Figure 62).

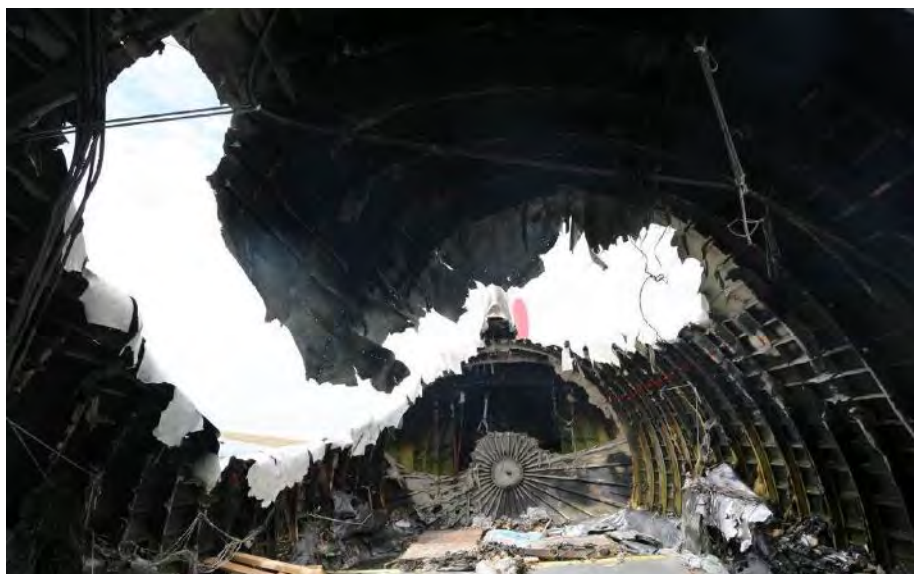
Figure 63 The Aft Pressure Bulkhead and Aft Main Deck Compartment Damage

b) The upper part of the aft pressure bulkhead and aft crown of the main deck cargo compartment were completely burnt-out, while the lower part of which remained, indicating the fire damage was more severe on the right side (Figure 63). Goods on the left side of PR position in the main deck cargo compartment were only superficially damaged by the fire and partly collapsed to the right side, while goods on the right side was seriously burnt and collapsed onto the PR pallet, indicating the fire damage was more severe on the right side (Figure 64).

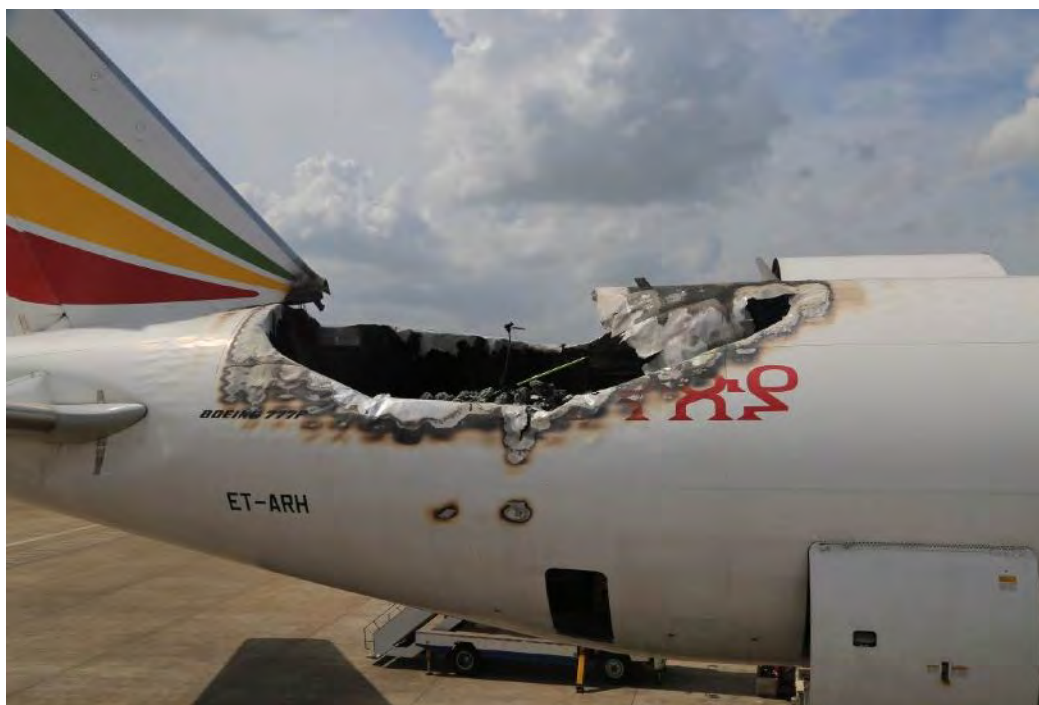
Figure 65 Fire Damage and Heat Discoloration Trace at PR Position (Outer view)

showed a V-shape, the burning severity gradually diminished toward the front and the rear from this point (Figure 65-67).

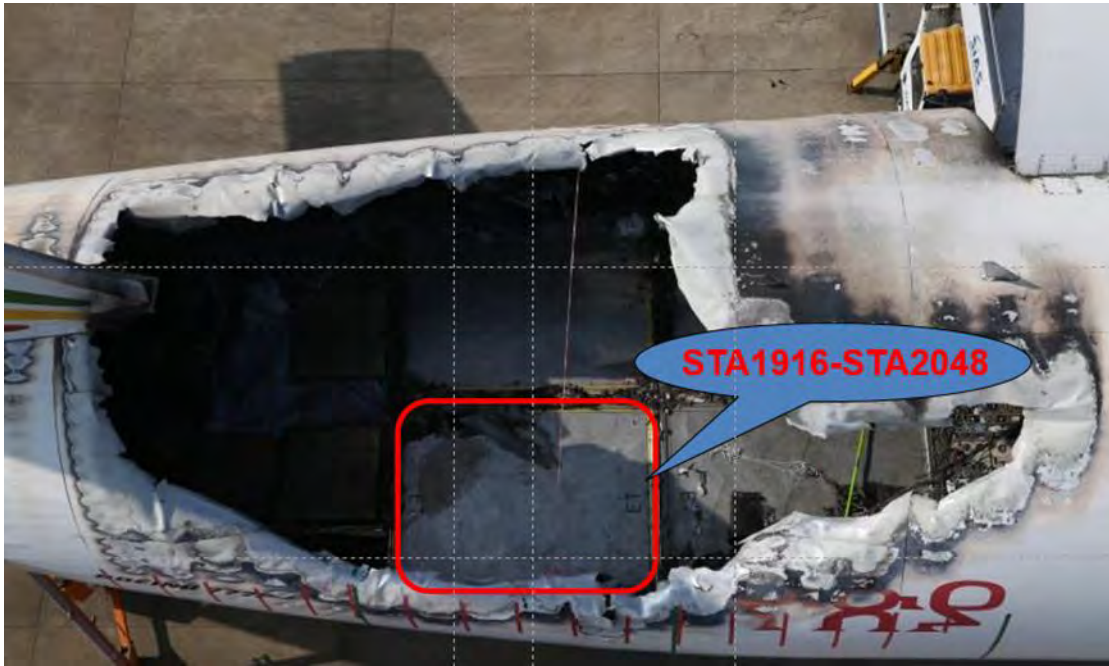
Figure 70 Bird View of PR Position

that the fire started from PR position, located on the right side of the main deck cargo compartment between station STA1916 and STA2048 (Figure 70).

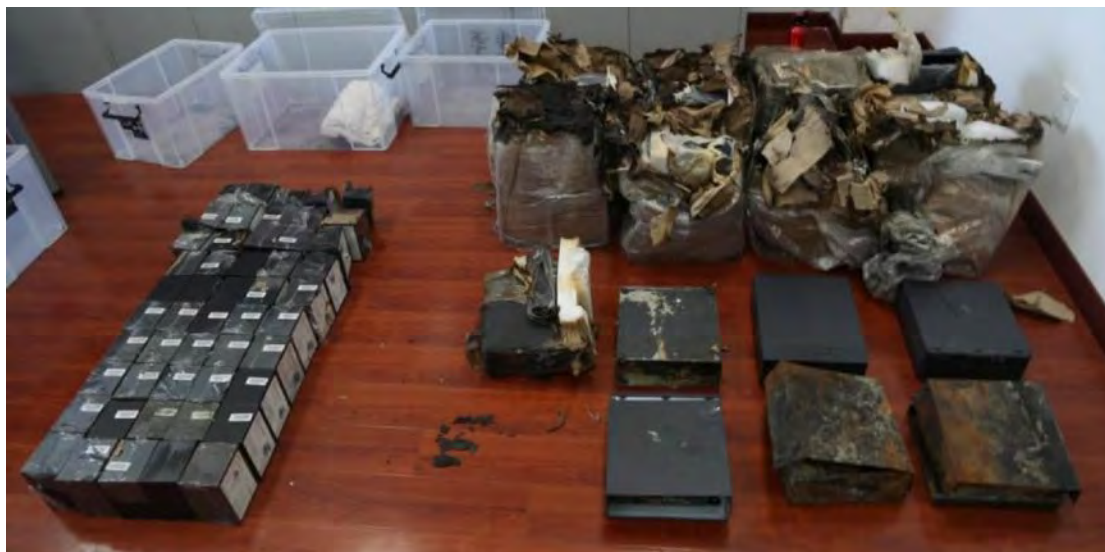
Figure 71 Damage to Mesh Nebulizer and Hisense POS product

The site survey found 50 mesh nebulizers on position R, 15 Hisense POS products on position PR, in consistence with the product name, quantity and position declared on the air waybill. Each product was examined, the mesh nebulizer was mostly intact, only part of their plastic packaging was molten. 2 out of 15 Hisense POS products were damaged seriously. After the disassembly, it was found that the metallic enclosure discoloured due to heat, and the discoloration is more serious on the outside surface than the inner side. The circuit board was comparatively intact. The damage was deemed caused by fire from the outside (Figure 71, Figure 72).

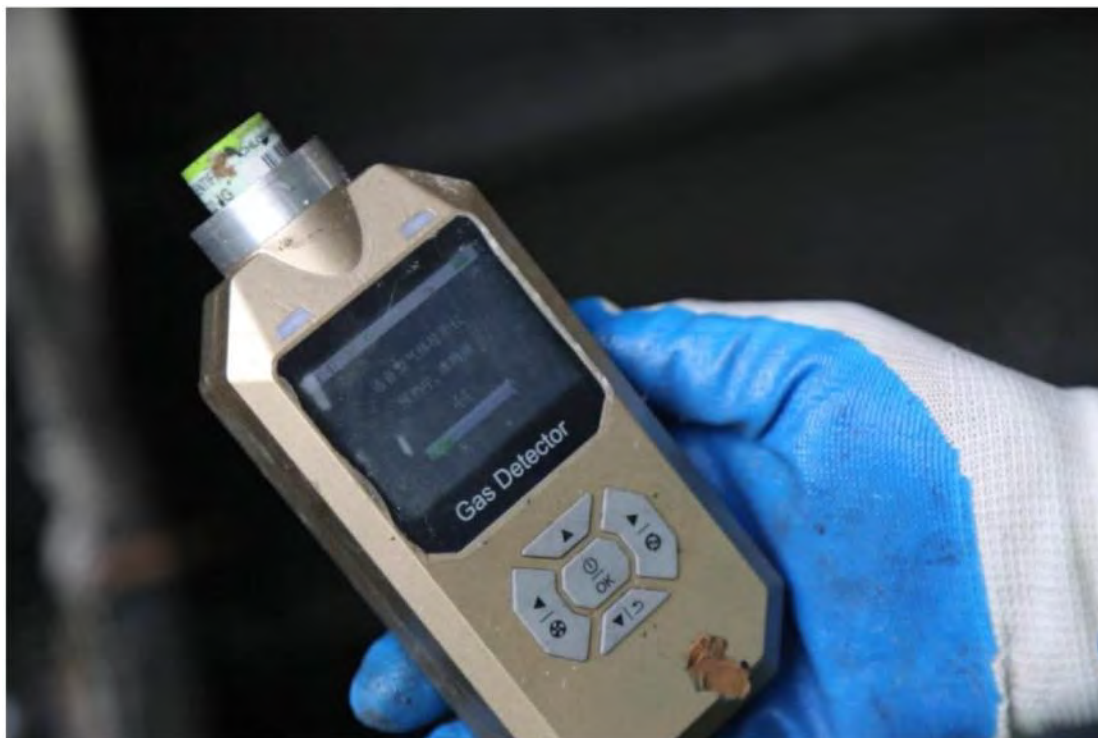
Figure73 Chlorine Dioxide Gas Detector found on Position PR

In addition, a chlorine dioxide gas detector was found on position PR, the product name was not on the air waybill. The examination showed that the embedded power plant was lithium battery. There was no damage to the detector. The site survey did not discover any more lithium battery or embedded lithium battery equipment or device (Figure 73)
