## **ULM-A-016/2016**

Accident involving a RANS S6 Coyote II aircraft, registration EC-YDQ, in the vicinity of the “Los Garranchos” airfield (San Javier-Murcia) on 15 July 2016.

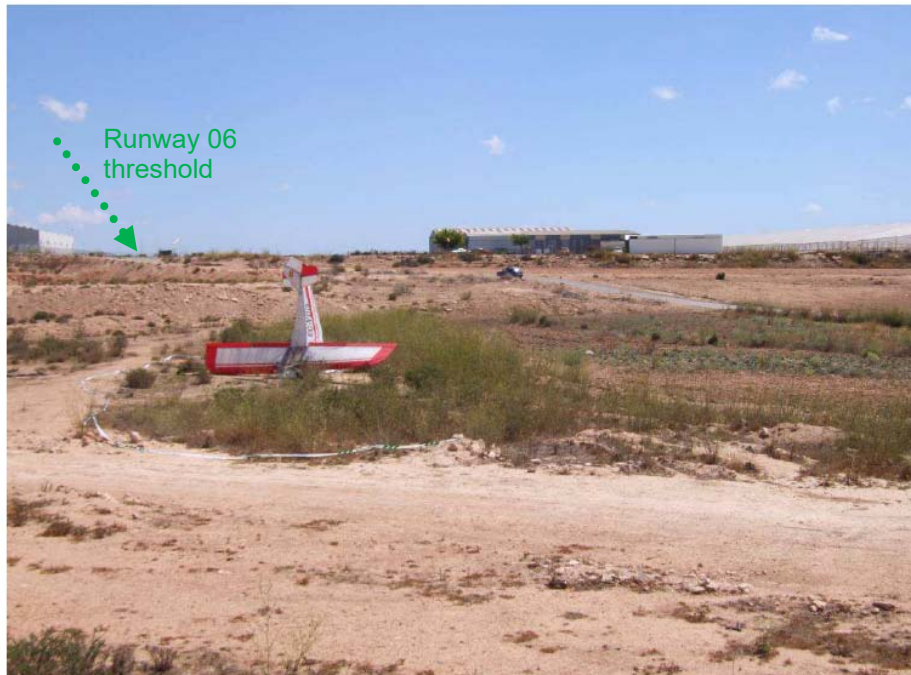
On the day of the accident there was nobody in the airfield. The Civil Guard contacted the flight manager to inform him of the accident. Upon his arrival, there were two eyewitnesses helping the pilot. One of the passersby told him that the aircraft’s engine had stopped and the aircraft was moving erratically.

**Photograph 1: Aircraft after the accident**

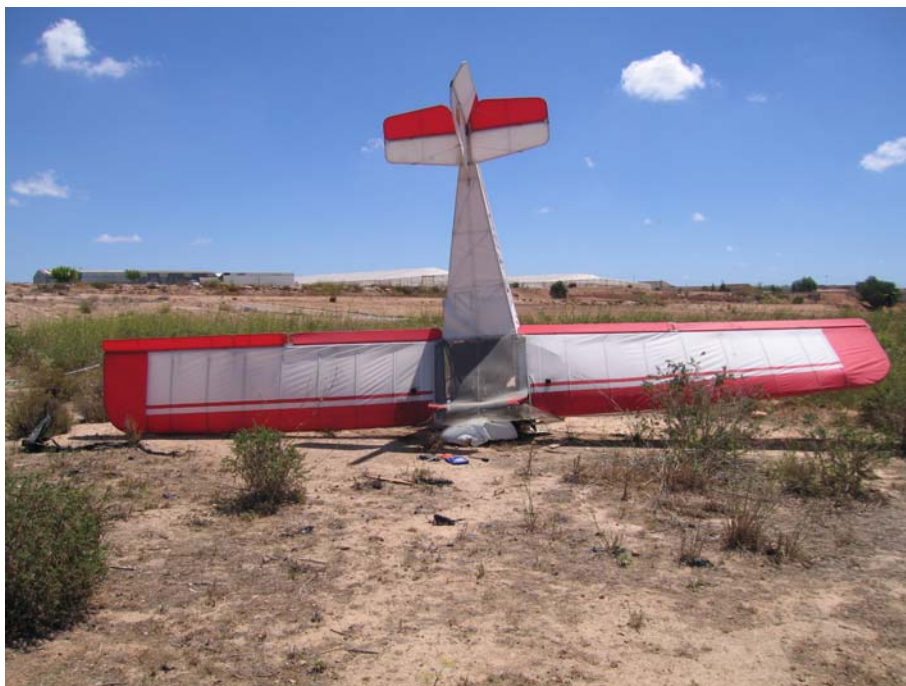
The aircraft was seriously damaged. As a result of the efforts made by Murcia GEDEX<sup>2</sup> personnel to deactivate the ballistic parachute, the aircraft caught fire and was destroyed.

***Photograph 2: Aircraft after the accident before GEDEX personnel took any actions***

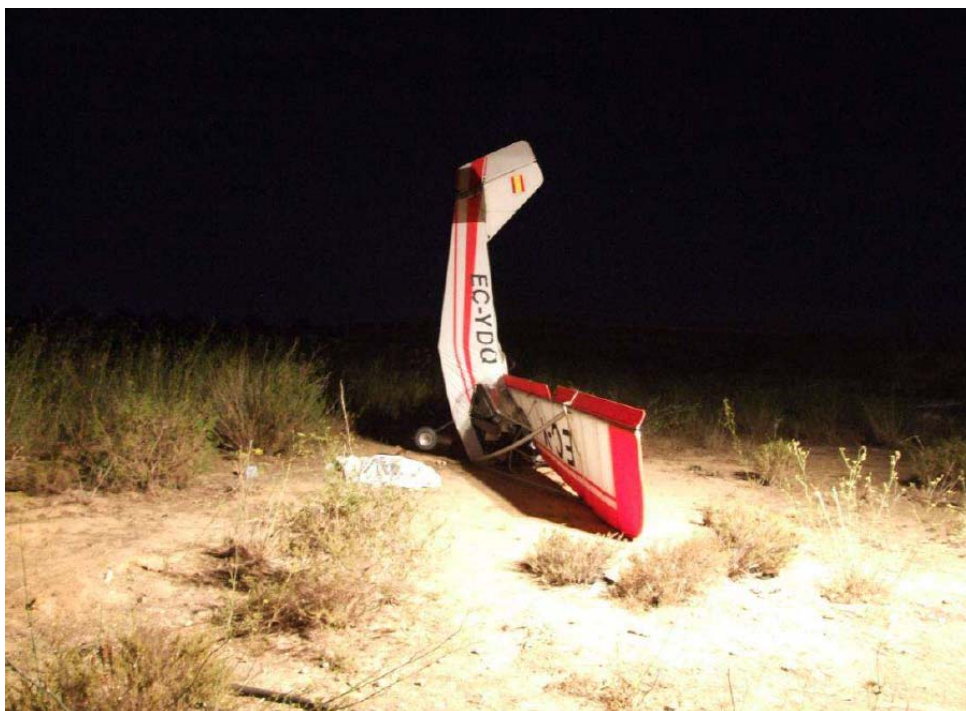
The aircraft was found in the vertical position with the nose touching the ground and the tail in the air in a nose-down attitude. It was at coordinates 37° 50' 41.33" N and 0° 52' 54.95" W and facing 280° (opposite heading to the flight path it was taking to reach the runway, see *Photograph 1 and Appendix 1*). The main wreckage was confined to a small area. A few centimeters away were wooden fragments from the propeller. The inside of the cockpit was crushed and the control panel broken.

All of the control surfaces were in good condition. The cables and control linkages were visible, provided continuity and moved freely. The flaps were not deployed and the right aileron was deflected upward, though it could have been moved into this position by the impact or when the pilot attempted to exit the aircraft.

***Photograph 3: Aircraft on the evening of the accident***
