# The GRF implementation of Beijing Capital International Airport

**ZHANG MIAO**

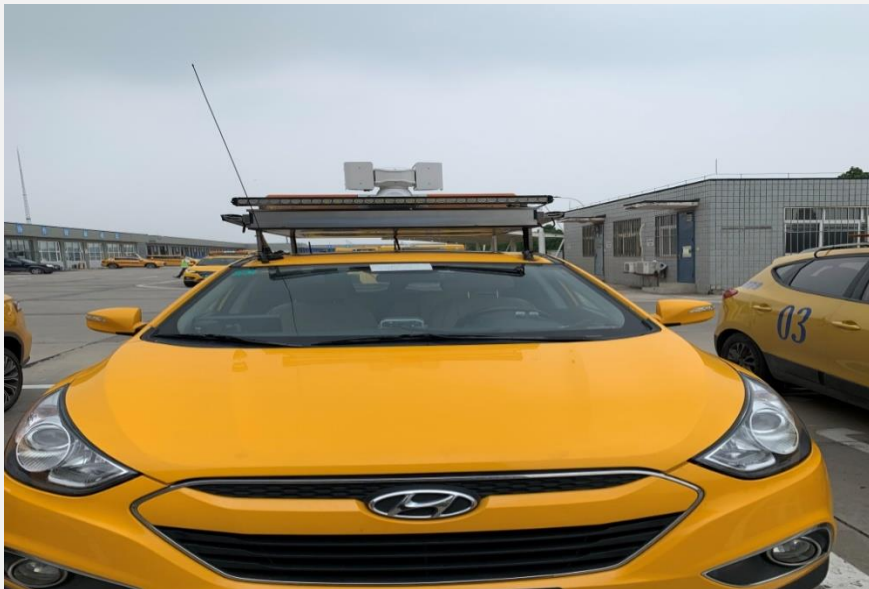
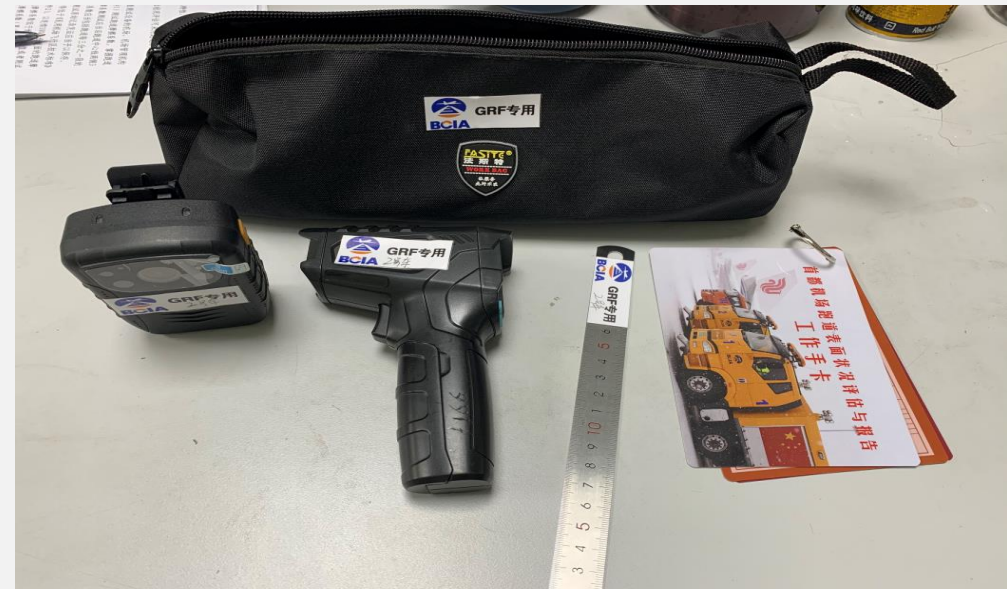
BCIA deeply analyzed the characteristics of the on-site assessment work, and provided the on-site operators with tools, such as rulers, thermometers, and video recorders. For the problem that it is difficult to measure water depth above the pavement of rainfall in summer, in order to increase the intuition, operators can consider using paper to distinguish the boundary at key positions such as 3 mm and 4 mm on the ruler. At the same time, combined with the summer climate characteristics, operators are equipped with raincoats, rain boots, goggles and other labor protection supplies. In order to ensure the real-time monitoring of the on-site situation, the vehicle is equipped with auxiliary equipment such as on-board video monitoring system and enhanced lighting.

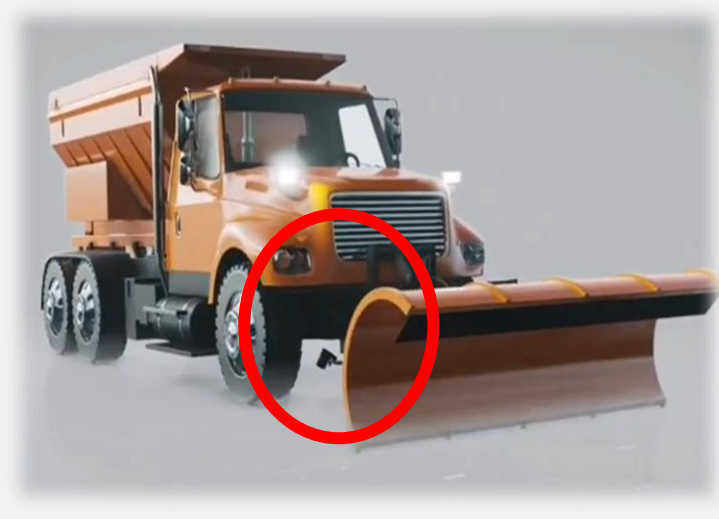
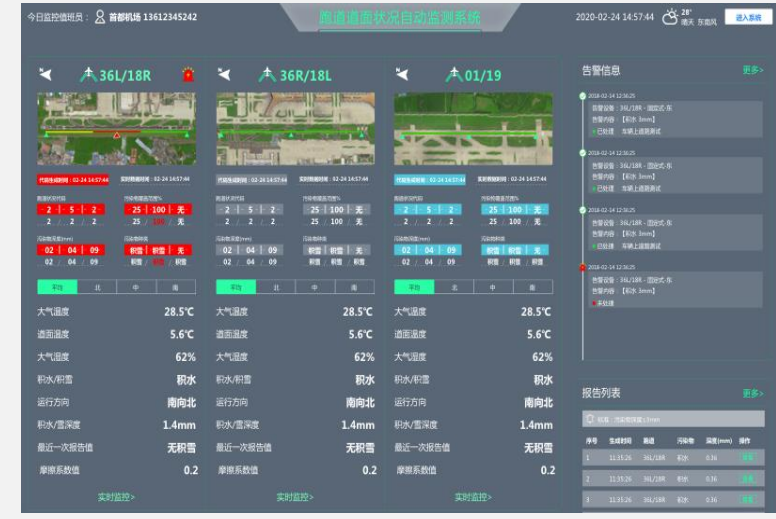
In May 2021, according to the future work plan of GRF, the BCIA began to build an intelligent auxiliary system for runway surface condition assessment. As of now, the system has initially provided the following functions: Firstly, the fixed station uses sensors for pavement surface monitoring, which can accurately monitor real-time changes of runway conditions, obtain data on the temperature, humidity, water depth, and snow depth on the runway surface, and transmit them to the monitoring center. The second is that the mobile station intergrated with the detection radar equipment which is installed on the front of the vehicle, and continuously and linearly collects and uploads the pavement surface water and snow data within the vehicle's driving track. Thirdly, the software systems record on-site video, real-time data and alarm information throughout the process, establish a full-process database, and realize the full traceability of the assessment process.

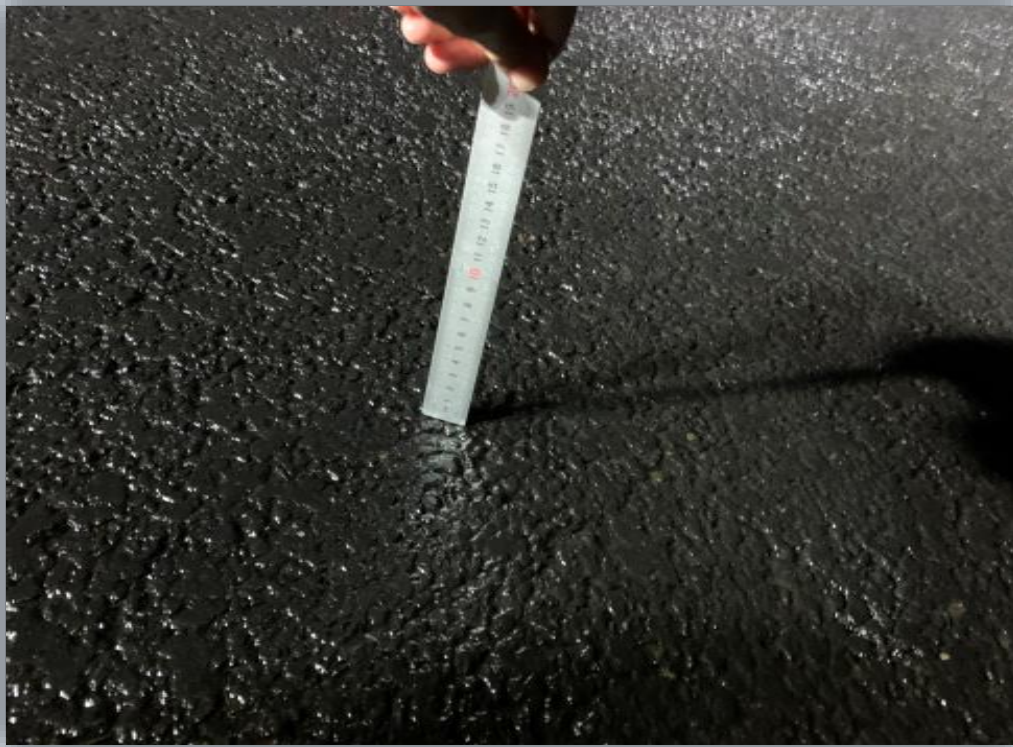
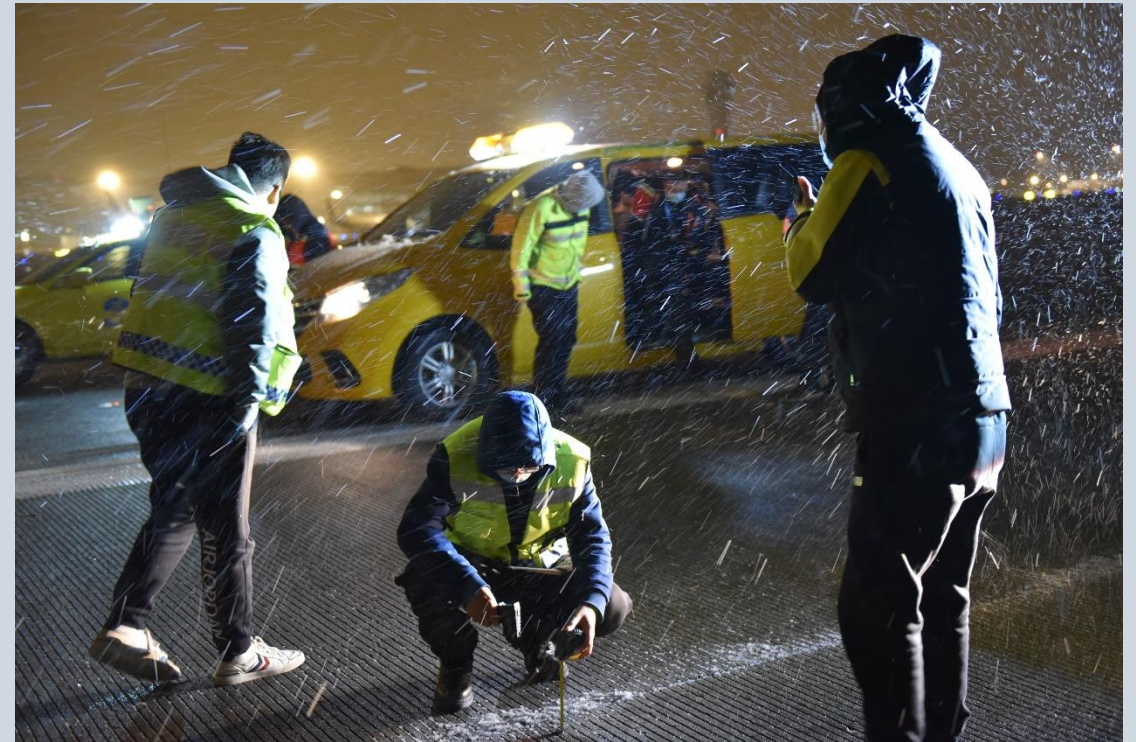
Manual measurement of pavement pollutant depth  
in rainfall / snow weather (mm accurate value)

**Challenge 2: straightedge and visual assessment are prone to deviation, and the authenticity of runway conditions is not guaranteed.**

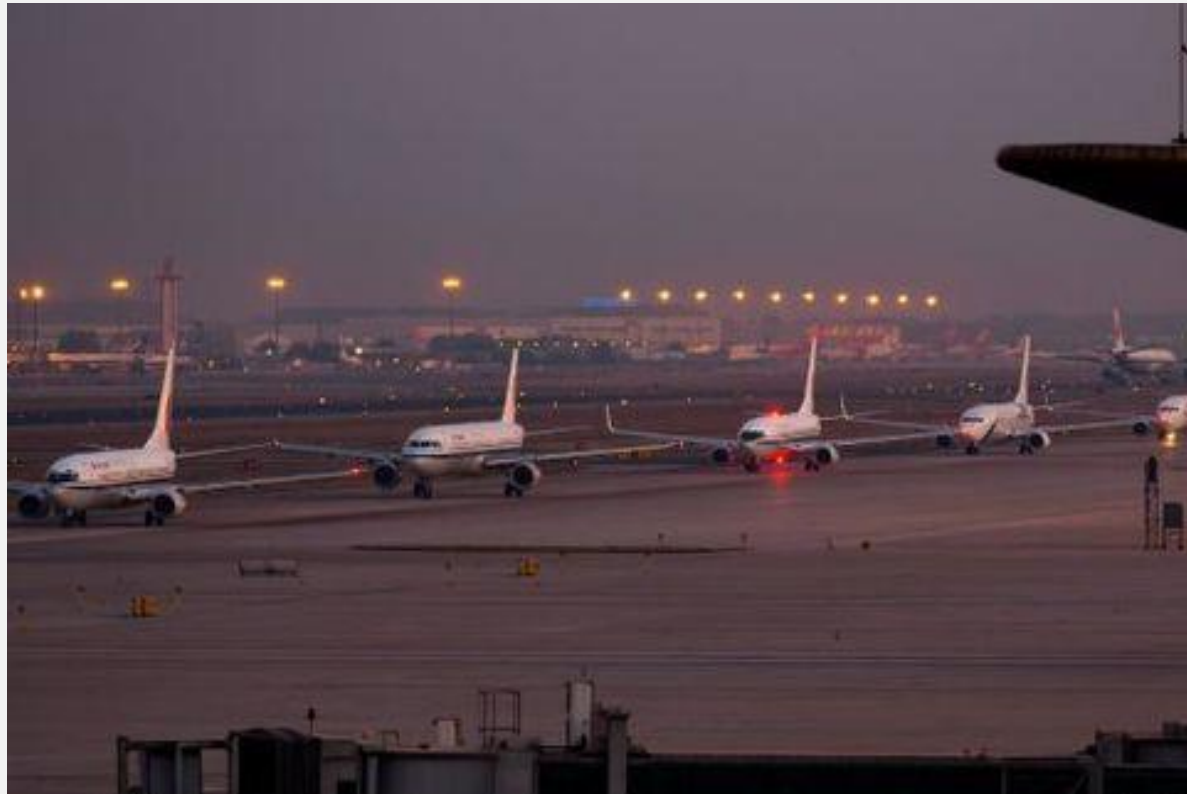
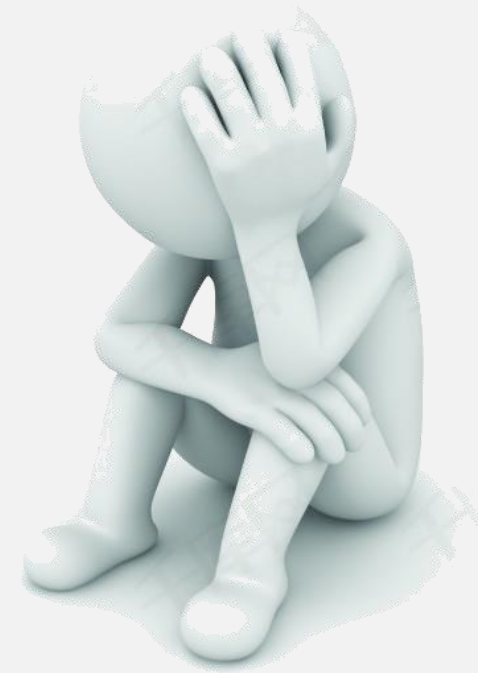
**Challenge 3: extend the runway occupation time, and the flight normality is not guaranteed.**

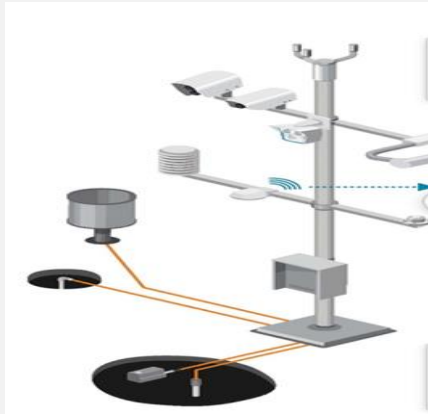
The runway shall be measured by fixed station

## Challenge 1 ✓ ----- construction of GRF auxiliary system fixed station

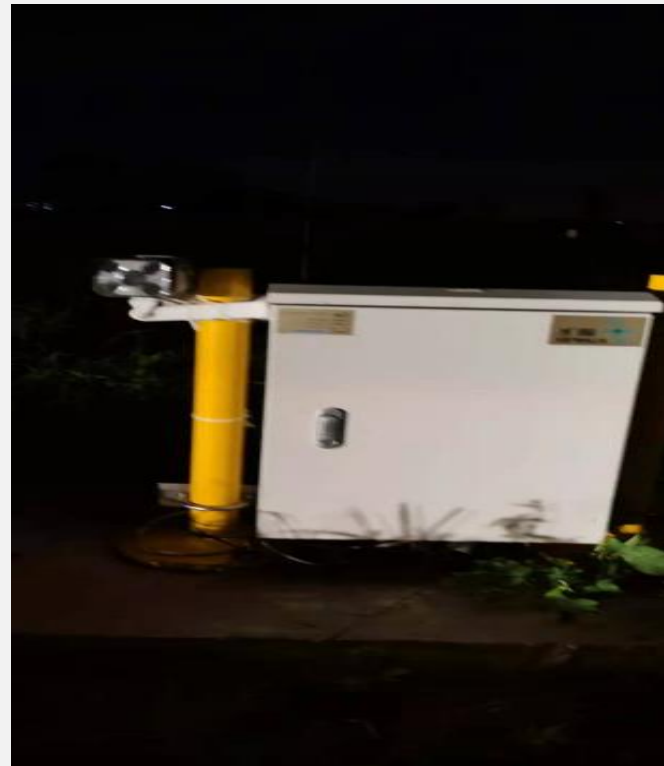
Side lamp fixed point  
(pollutant range)

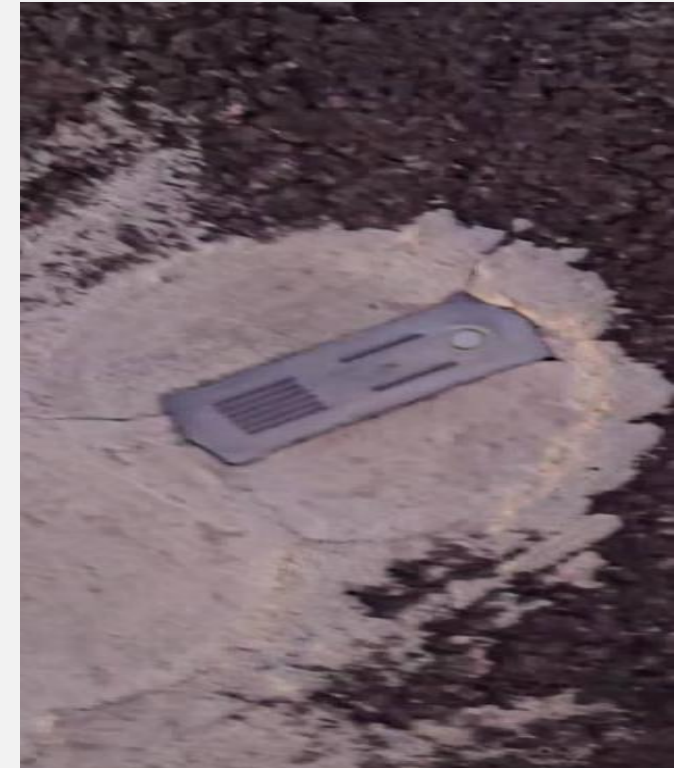
Embedded monitoring equipment  
(measuring pollutant depth and  
identifying pollutant type)

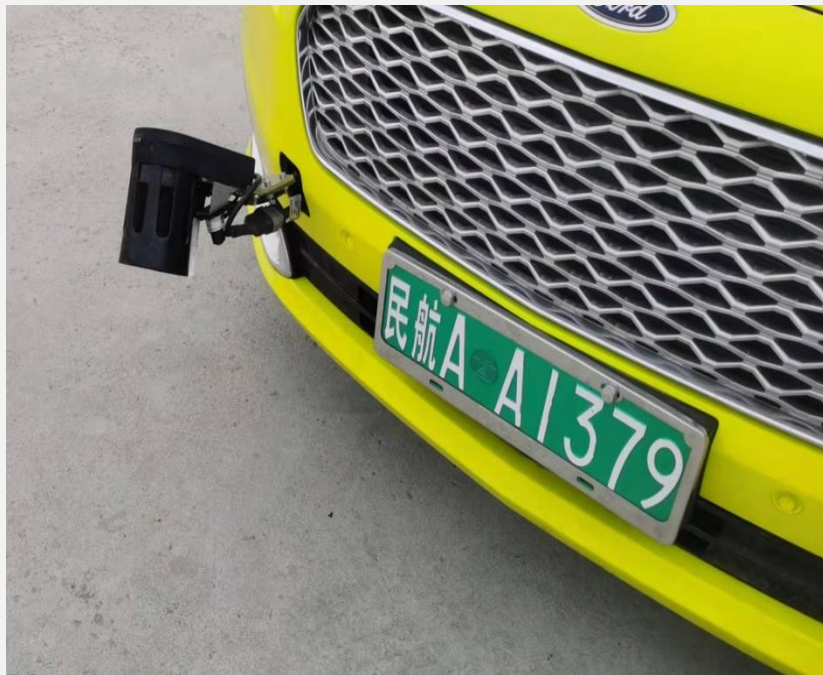
**Mobile station  
auxiliary survey**

Challenge 2 ✓ challenge 3 ✓ construction of mobile station of GRF auxiliary system

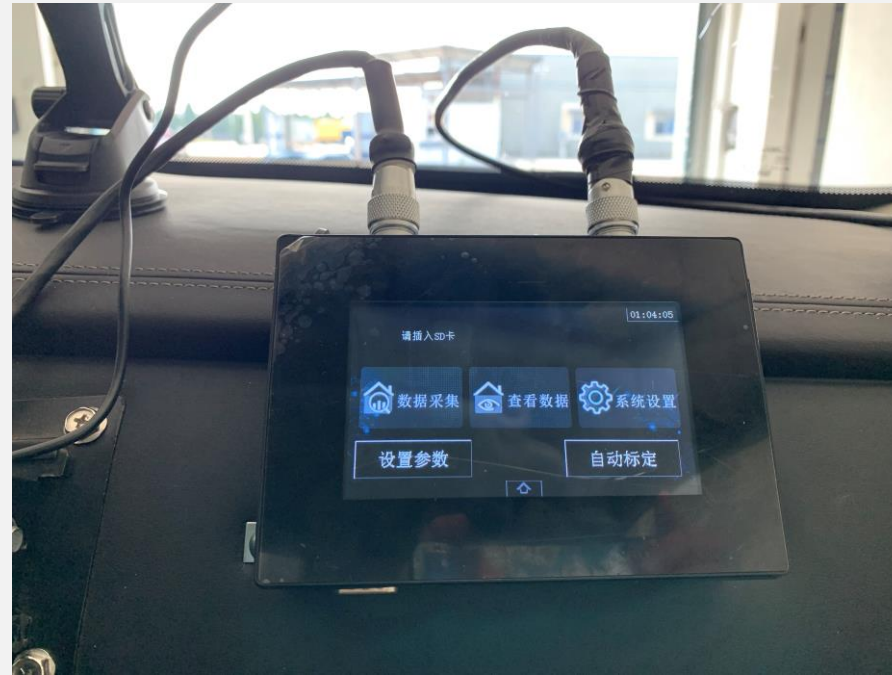
**App terminal automatically  
records collected data**

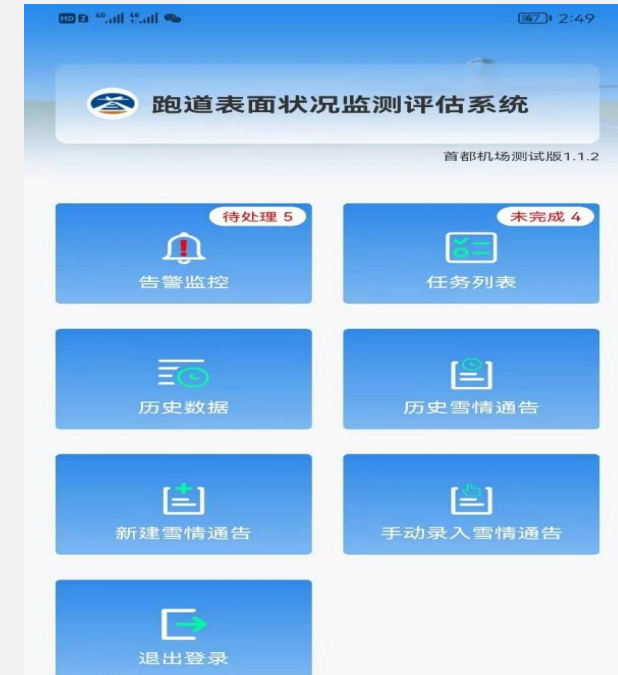
**Remote transmission  
of assessment results**
