# The ADS-B Webinar

# Aireon ALERT

### Global Air Traffic Surveillance Challenges

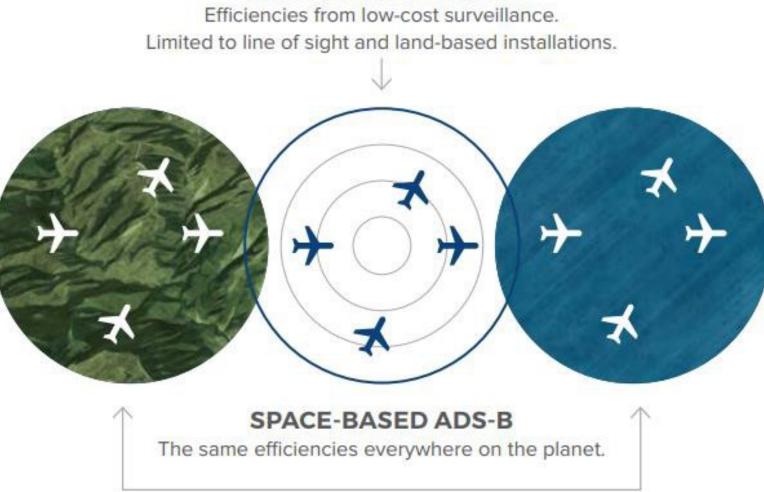
## Line of Sight Limitations

#### **GROUND-BASED ADS-B**

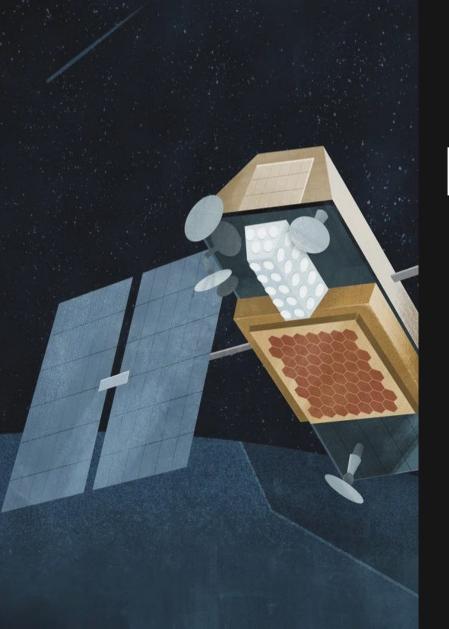
#### **Iridium Constellation Overview**

**66** Total number of satellites in the Iridium NEXT Constellation

11 satellites per plane Plus

9 in-orbit spare satellites

6 ground spare satellites

**Orbital Planes: 6**

Availability: ≥ 0.999

Typical Lifecycle: 14 Yrs

**Operational Altitude: 485 miles (780 km)**

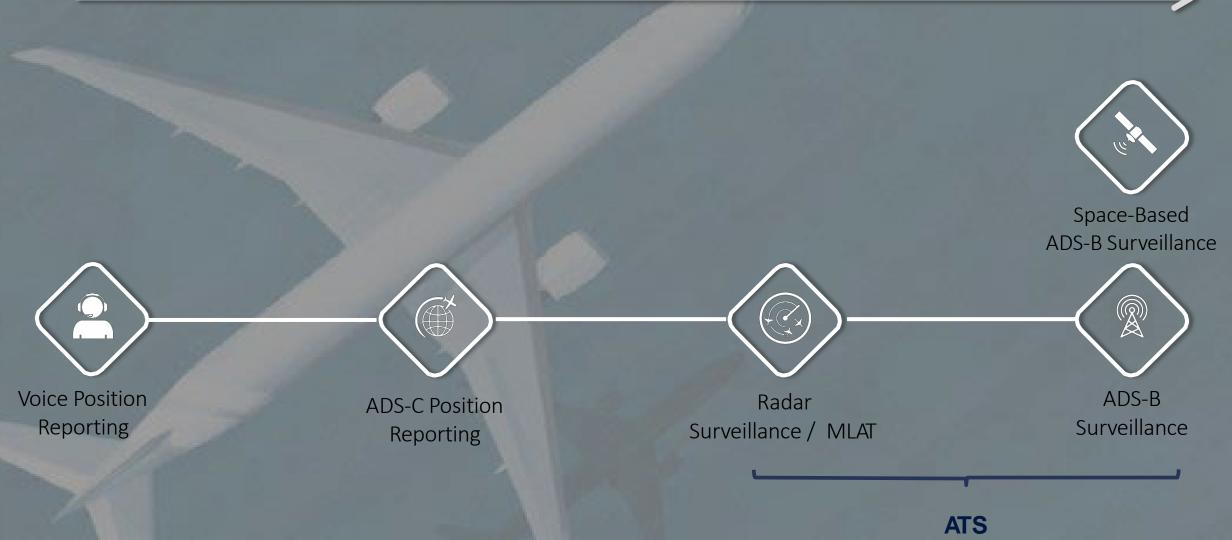
### **Position Accuracy / Update Interval**

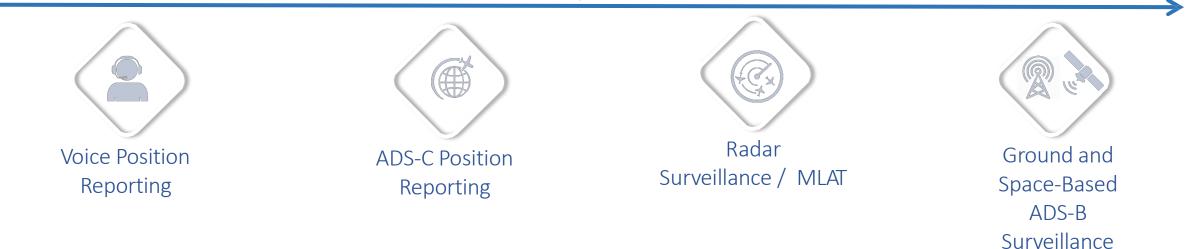
#### **Position Accuracy / Update Interval**

Narrow Body Aircraft	Wide Body Aircraft
Potential Search Area	Cruise Speed (Knots)	427	475
(Sq Km)	PIREP (30min)	491,165	607,798
	ADS-C (15min)	122,791	151,949
	Space-Based ADS-B (8sec)	9.7	12

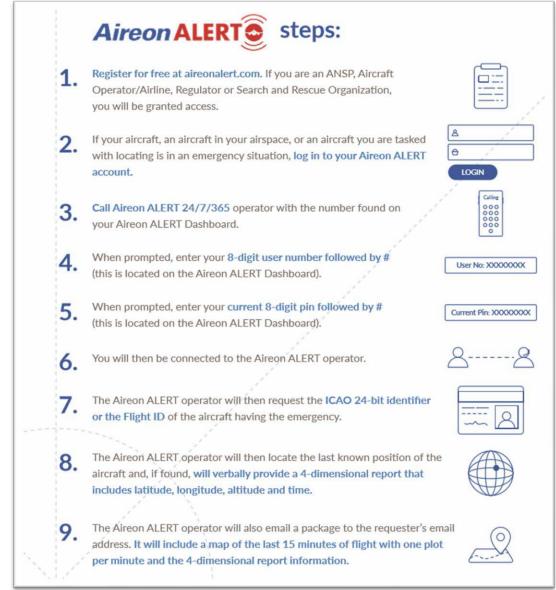
### **How Does Aireon ALERT Work?**

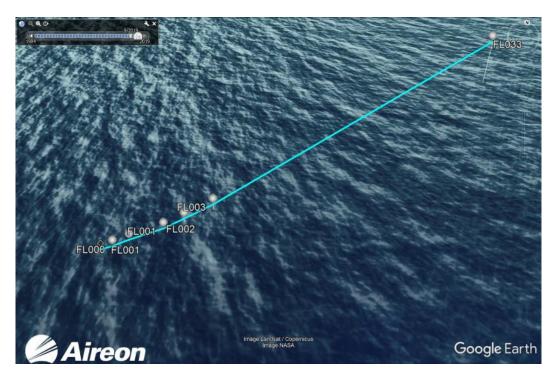
- On 23 December 2019 a request was made by a SAR team in locating a missing Cessna Centurion aircraft in the Bahamas
- The last known radar target from FAA was received at 1300 feet and rescue was dispatched to that location to start a search grid
- Aireon data showed the last position >2NM away from last FAA position, allowing SAR to immediately direct the helicopter to the right position
- The pilot was found <u>ALIVE</u>, treading water in the ocean without a lifejacket as the plane had already sunk

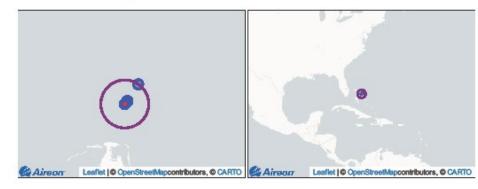
#### Search Criteria: FLIGHT ID N50DH

Timestamp	ACID Mode 3/A	Latitude	Longitude	FL	Speed	Heading
2019-12-23 16:08:25 UTC	N50DH 2499	25° 42' 05" N	076° 38' 58" W	FL000	72.0	226
2019-12-23 16:08:21 UTC	N50DH 2499	25° 42' 08" N	076° 38' 54" W	FL000	72.0	231
2019-12-23 16:08:14 UTC	N50DH 2499	25° 42' 13" N	076° 38' 48" W	FL001	72.0	223
2019-12-23 16:08:01 UTC	N50DH 2499	25° 42' 24" N	076° 38' 36" W	FL001	72.0	221
2019-12-23 16:07:53 UTC	N50DH 0000	25° 42' 32" N	076° 38' 29" W	FL002	72.0	218
2019-12-23 16:07:41 UTC	N50DH 0000	25° 42' 44" N	076° 38' 19" W	FL003	72.0	217
2019-12-23 16:03:34 UTC	N50DH 2499	25° 46' 28" N	076° 35' 39" W	FL033	36.0	213

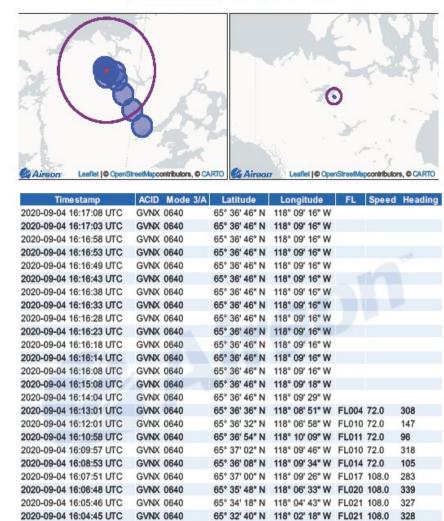
#### Search Criteria: ICAO C07D86

65° 31' 00" N 117° 59' 41" W FL022 108.0

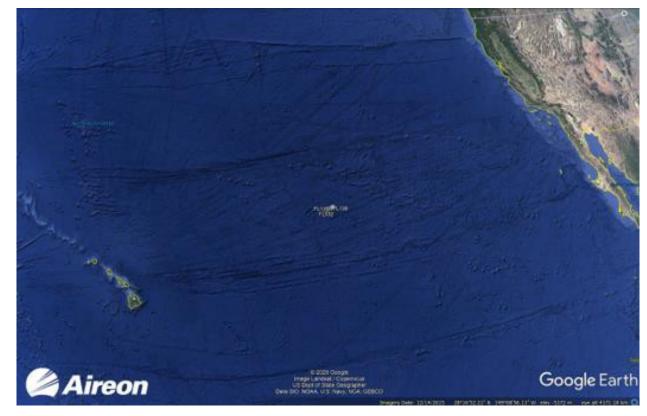
#### Search and Rescue Mission – Mid Pacific – 8th Nov 2020

- Pilatus PC-12, with 2 crew, declared a mayday with an engine failure mid-pacific.
- The aircraft successfully ditched mid-pacific 1100nm from land.
- Aireon ALERT data tracked the aircraft down to sea level, including multiple returns whilst the aircraft floated on the surface.
- The Aireon data confirmed the ELT position to within 0.57 NM and was crucial in aiding the recovery of the crew alive 5 hours later by a passing cargo ship.
