Aircraft Accident Investigation Report

Aircraft Fire on Ground
Ethiopian Airlines, Flight ET3739
Boeing 777F, Registration ET-ARH
Pudong International Airport
Shanghai, P.R. China
July 22, 2020

Report No. 20200722YDSQ01
Aviation Safety Committee
Eastern Regional Administration of Civil Aviation Administration of China
December 30, 2021

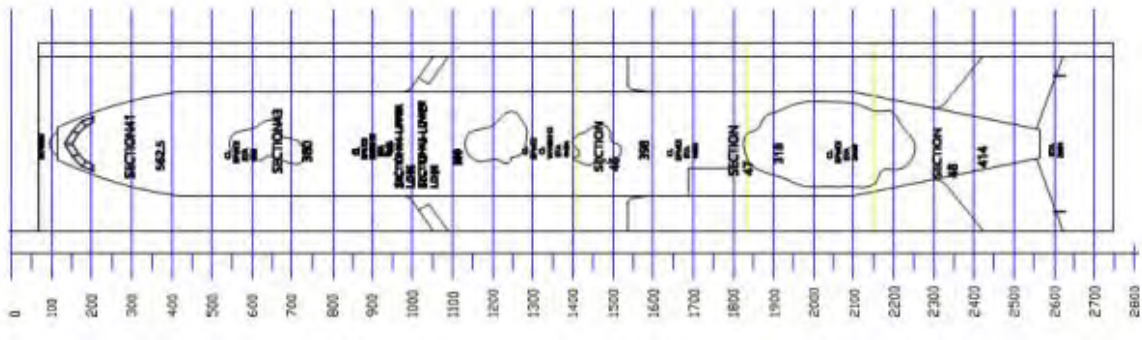
Figure 2 Damage Diagram

The skin, main structural components such as frames and stringers of the upper fuselage from section 41 to 48 were damaged by the fire (Figure 2). Multiple burn-through areas were presented in the crown centerline, of which the most severe area was section 47 (Figure 3) (STA1832-STA2150). The skin, frames and stringers above stringers S24L and S24R were burnt out. There were two large, ablated skin areas above the bulk cargo door of the right fuselage between stringer S24R and S27R (Figure 4). The remaining fuselage structures sustained extensive thermal damage and sooted. The dorsal fin skin and structures of the vertical stabilizer were burnt out (Figure 5). The radial stiffeners, doubler and frame chords of the aft pressure bulkhead were mostly burnt out (Figure 6).

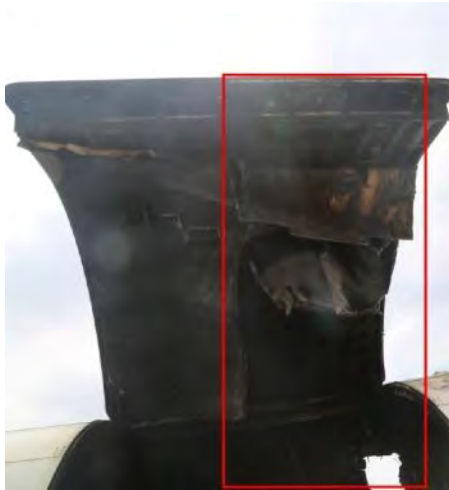
Figure 8 Main Deck Cargo Comp. Door

Components installed on the top of the main deck cargo compartment such as the ceiling panels, heat insulation cotton, smoke/fire detectors, light assemblies, sidewall panels, air condition ducts, wiring harness (including APU main feeder cables), wire mounting brackets, electrical plugs were burnt out (Figure 7). The interior linings of the main deck cargo compartment door were extensively burnt down, and the door structure was severely heated, which was stuck in the open position and could not be manually closed (Figure 8). The main deck cargo compartment floor in front of the aft pressure bulkhead was burnt through (Figure 9). The rigid cargo barrier in the main deck cargo compartment also sustained extensive thermal damage (Figure 10).

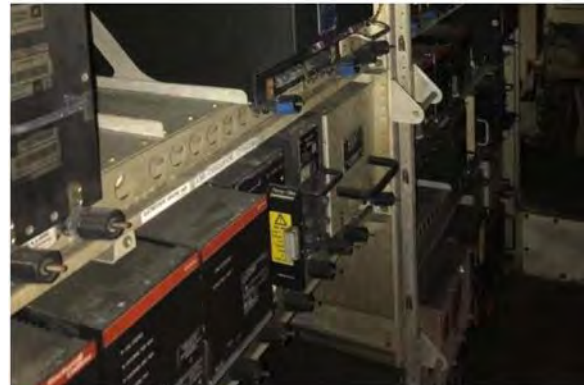
Figure 12 E/E Bay

The structures of the forward and aft lower holds in the lower lobe were intact. After removing the side wall panels of the forward lower hold, the structures, ducts and equipment were obviously sooted (Figure 11). Most of the electronic equipment in the E/E bay were also sooted (Figure 12). The APU compartment was intact and no trace of fire or soot.

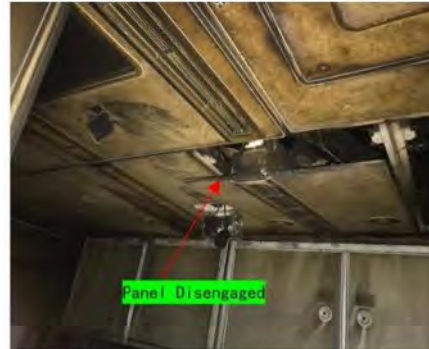
Figure 14 Panel Disengaged in the Supernumerary Area

The overhead panels in the cockpit and supernumerary area were disengaged due to overheating (Figure 13 and 14). The internal furnishings, linings and components were sooted.

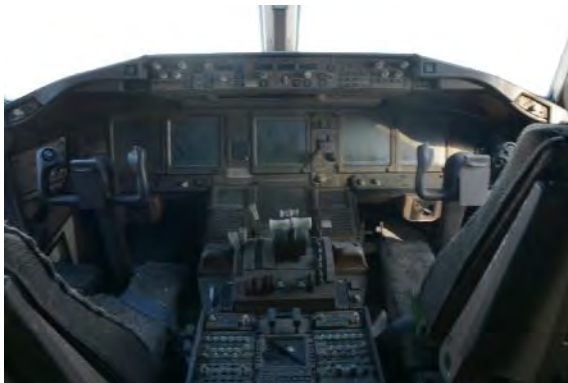
Figure 15 Sooted Cocpit

The cockpit was obviously sooted. The APU fire switch was not pulled out. All flight crew oxygen masks and portable breathing equipment (PBE) were in place. The protective cover of DEPR/DISCH switch on the CARGO FIRE/ENGINE CONTROL PANEL (P5) was lift, and the CARGO FIRE ARM SWITCH was in armed position. The APU selector was set to ON, and the main battery switch was set to OFF (Figure 15 to 20).

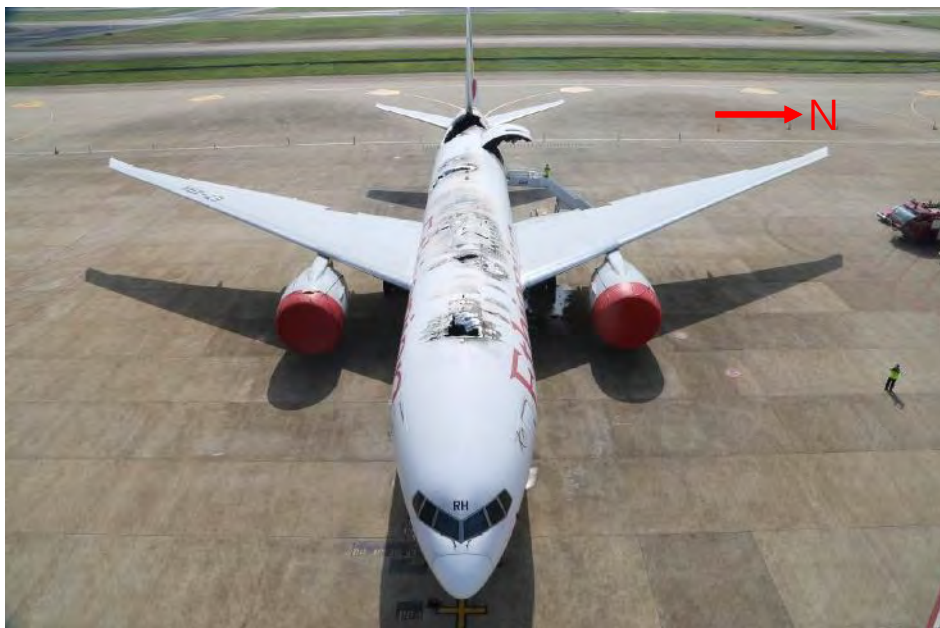
Figure 40 Damaged Aircraft

Ethiopian Airlines B777F freighter, registration ET-ARH, docked at parking position No.306 of Pudong Airport with its nose heading east. The fire only damaged the aircraft, while the airport cargo terminal to the east, the taxiway B to the west, the parking position No. 307 to the south, and the parking position No. 305 to the north were not affected (Figure 40). The aircraft sustained several burn-through damages in the upper fuselage, and the interior linings of the main deck cargo compartment was seriously burnt out. The main frames and components of the lower fuselage remained intact but got partially sooted, which could be suffered from thermal damage. No obvious fire or soot trace were found in the areas of wings, engines, landing gears, stabilizers and APU. The details were described in section 1.3.

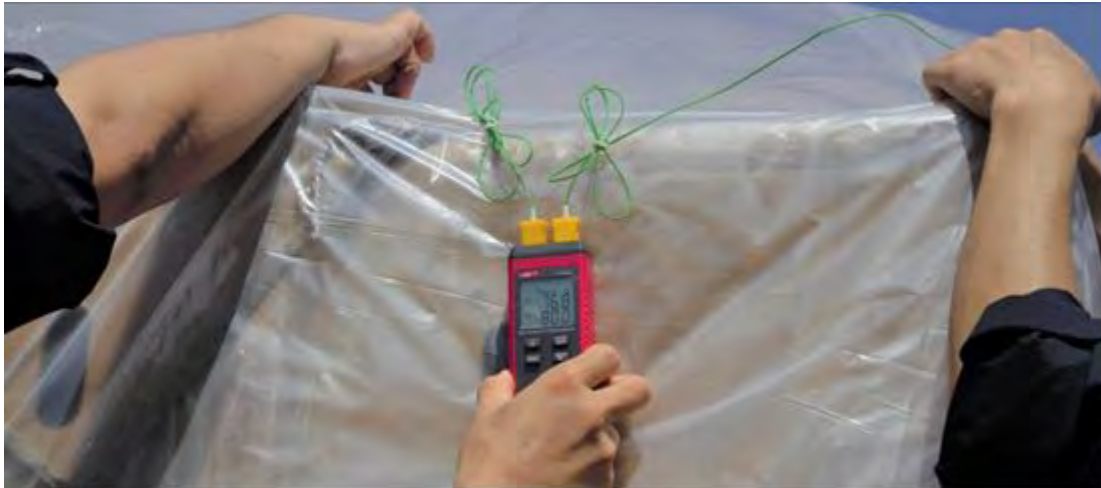
Figure 43 Stack internal temperature

On August 20, 2020, the investigation team simulated the process of the transport by using stack packaged in the same way as the goods mentioned above. The simulated stack was exposed to the sun. On the day of the simulation, the temperature at Pudong Airport was 26°C-34°C (33°C at 12:00), and the humidity was 59%-95%. At about 13:00, the temperature of the stack was measured, and the ambient temperature inside the stack reached 80°C. At the same time, the condensation was found in the plastic film.

It was possible that chlorine dioxide disinfection tablets of the goods were exposed to high temperature and humid environment. (Figure 43 and 44).

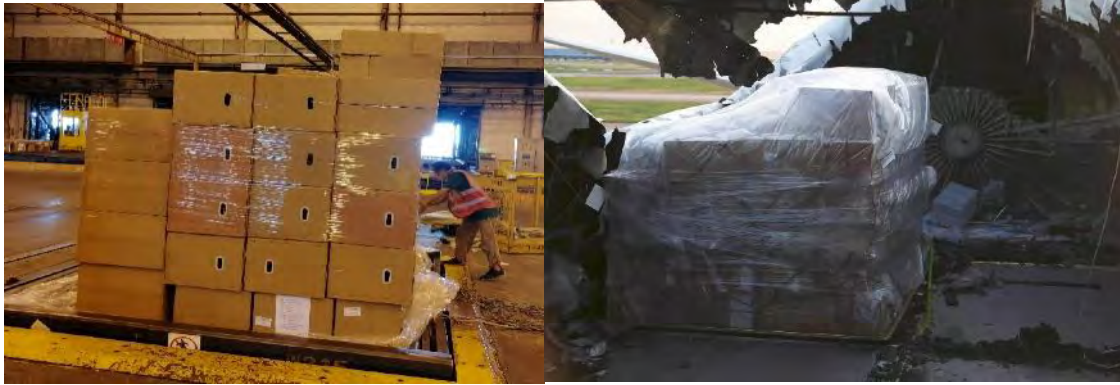
Figure 53 Pallet Reconstruction

After reviewing the good assembly video records and cargo photos of pallet PMC3324ET, the investigation team collecting articles like the packing cartons of the same batch and quantity, with the cooperation of the personnel responsible for loading the pallet PMC3324ET, accomplished the reconstruction of the pallet loaded at a ratio of 1:1. The replica was loaded on the accident aircraft where the pallet PMC3324ET had been placed. (Figure 53 and 54).

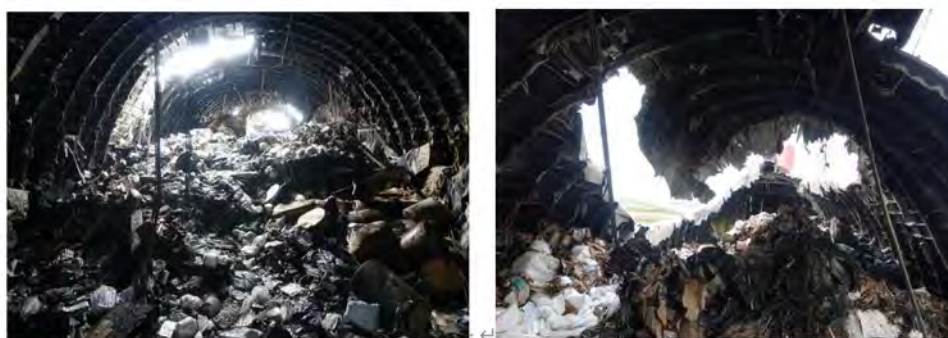
Figure 55 Main Deck Cargo Compartment (Forward and Aft Area)←

b) According to site survey, the entire main deck cargo compartment sustained extensive fire damage. The supernumerary area and the cockpit suffered high temperature smoke only. The aft area and the upper section of the right sidewall suffered fire damage. (Figure 55-59).

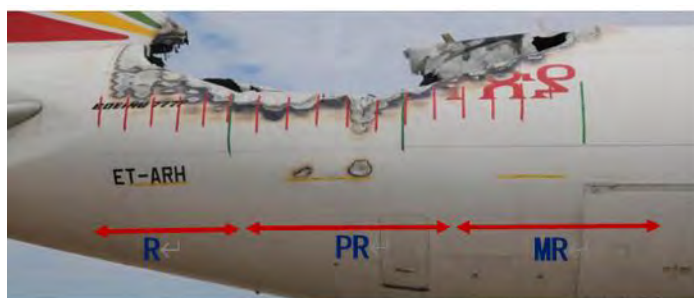
Figure 68 Marked Frames, Pallets and Floor Positions

e) The investigation team identified and marked the frames, pallets and the main deck floor in the fire-damaged area on the outer skin of the fuselage. According to this identification and the CCTV footage of the parking position No.307, area on the right side of the fuselage in which the skin presented the first heat discoloration, was located between station STA1916 and STA2048, the PR position in the main deck cargo compartment (Figure 68 and 69).

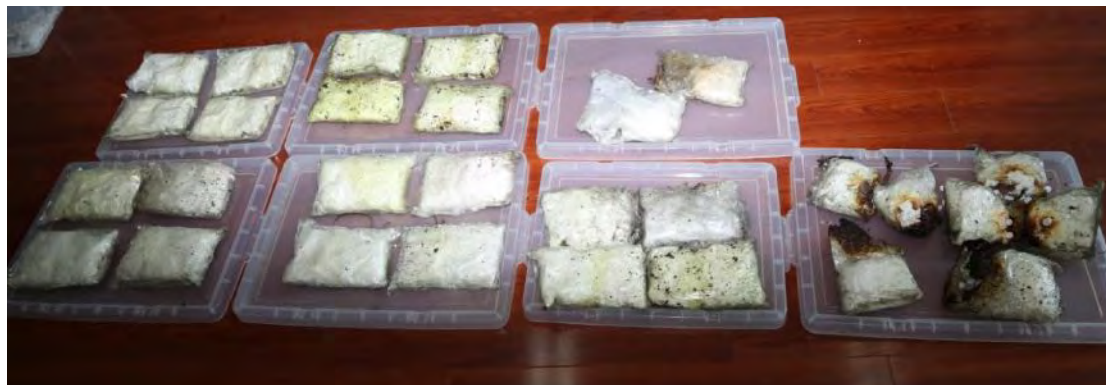
Figure 74 Chlorine Dioxide Disinfection Tablets

Sample 1 and Sample 2 (in Table 3) were chlorine dioxide disinfection tablets (Figure 74). According to site survey, there were 23 intact plastic bags (each weighing about 1kg), 10 broken plastic bags and 1 aluminum foil bag, all of which have no marks on them. Sample 2 was sent to the SRICI for qualitative test. The composition of the Sample sent for test was quite similar to that of disinfection products commercially available which can release chlorine dioxide, and the chlorine dioxide was produced when the Sample reacted with water. Samples 1 and 2, together with chlorine dioxide effervescent tablets purchased in the market, were sent to Tianjin Fire Evidence Identification Center of Fire Bureau of Ministry of Emergency Management for

appraisal and analysis. The conclusions are as follows: The Samples sent for inspection have a certain spontaneous combustion risk when they are damped at normal temperature, and the self-heating power of Sample 1 is much higher than that of commercial products, so the spontaneous combustion risk is extremely high. In case of unfavorable heat dissipation, it is possible to accumulate heat in a short time to reach the spontaneous combustion temperature.

According to Article 8.3 of "Solid composition releasing chlorine dioxide" (GB/T27802-2011), the chlorine dioxide solid releasing agent should be stored in a cool, dry and ventilated place to prevent damp, heat or sunlight exposure. Based on meteorological data and appraisal report, chlorine dioxide disinfection tablets at position PR were likely to be exposed to high temperature and moisture.

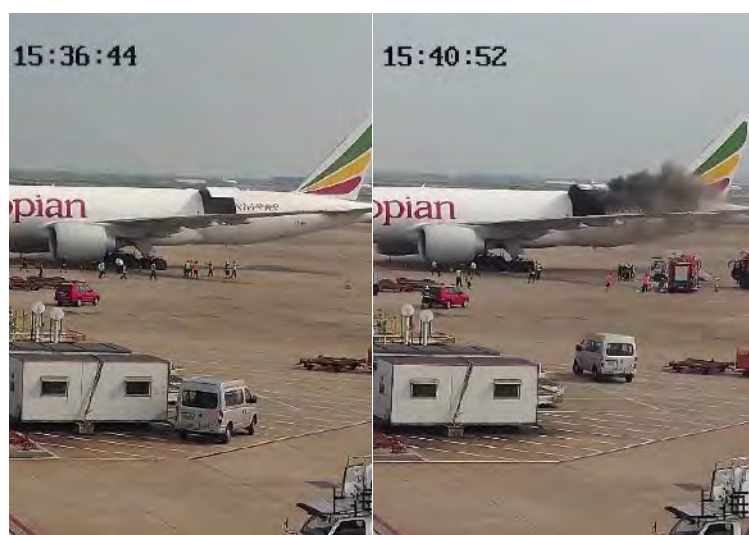
Figure 75 Screenshot of CCTV Footage from Parking Position No.305

According to the video footage and firefighters' statement, a small amount of white smoke came out once the aircraft main deck cargo door was opened, and turned into black smoke after about 4 minutes, which is in line with the characteristics of spontaneous combustion (Figure 75).

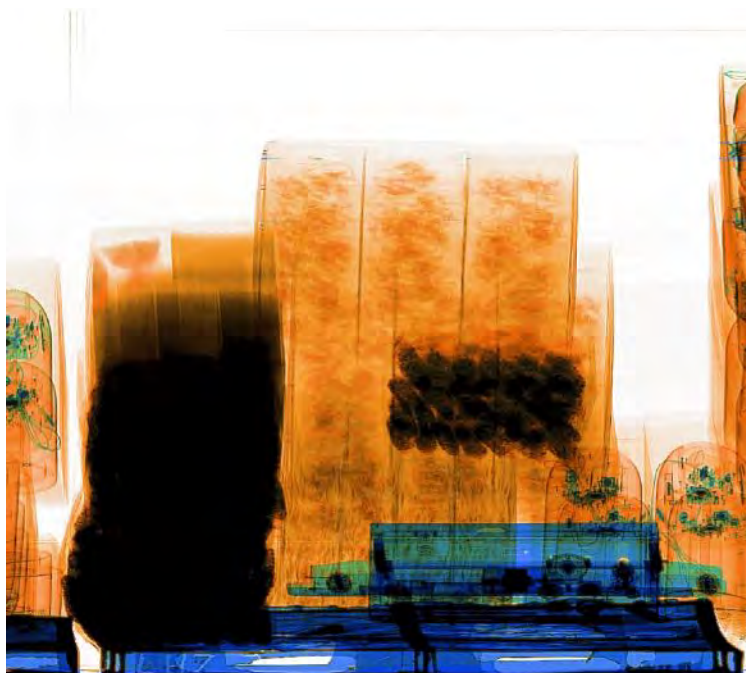
Figure 76 Security Inspection Image

The PACTL completed the examination of cargo transport documents. The goods entered the warehouse of PACTL after security inspection. The investigation team reviewed the X-ray machine images of the goods (Figure 76). The images showed that there were two areas with granular physical morphology, of which granular shape was obvious in the light color area, and in the dark color area, supported by image highlight function key, showed evident granular shape at the edge. It conformed the granule described in "Appearance & Odor" in the Certification for Safe Transport of Chemical Goods for nano slow-release disinfection material. According to Article

147 of CAAC Security Inspection Operation Manual, it is not within the category of the goods required to be unpacked check mandatorily.
