Pilot Response to EGPWS Alerts

Yasuo Ishihara
Technical Fellow
Honeywell Aerospace

EGPWS Descriptions

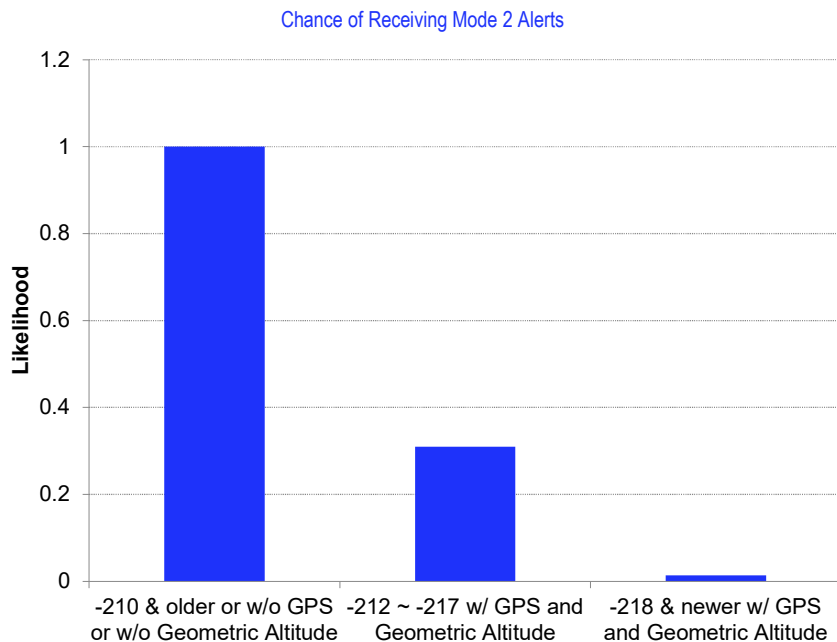
EGPWS Statistics

Summary of findings based on EGPWS event data analysis conducted by Honeywell.

- **Mode 1 (Excessive Descent Rate)**
 - 89% of Mode 1 alerts occurred below 500 ft radio altitude, and 67% below 200 ft radio altitude.
- **Mode 2 (Excessive Terrain Closure Rate)**
 - 98% of Mode 2 alerts occurred on airplanes with EGPWS software version older than -217 (or Boeing P/N 965-1690-050 or Airbus P/N 965-1676-001) or without GPS or without Geometric Altitude.

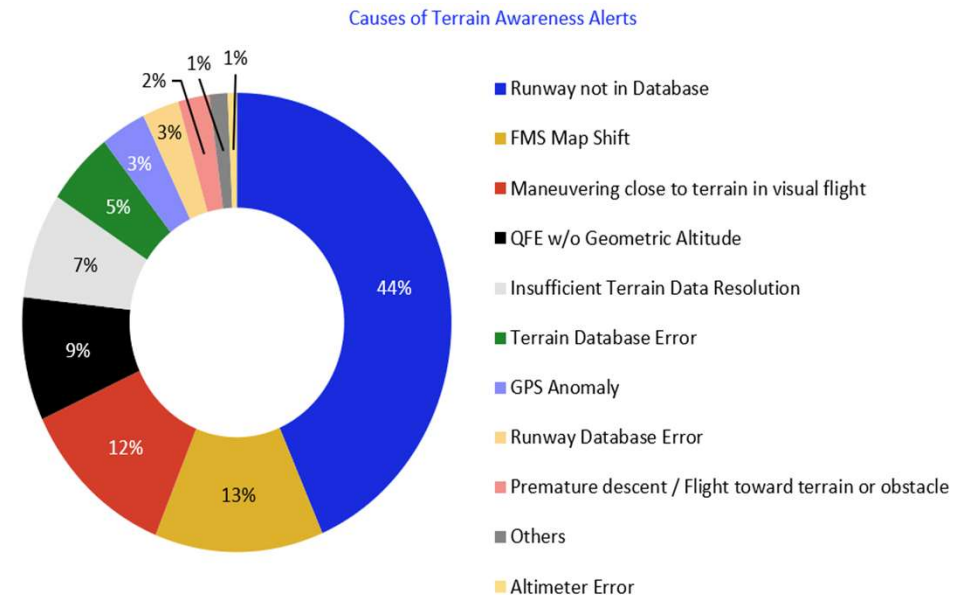
- Some causes of Terrain Awareness alerting and TCF/ Runway Field Clearance Floor (RFCF) functions are shown in the figure below.
- Majority of the alerts were caused by external signal faults (e.g., FMS map shift or altimeter error) and terrain/obstacle/runway databases. Nearly a half of Terrain Awareness and TCF/RFCF alerts were caused by not having a destination runway in the database.
- This often meant the latest terrain/runway database was not installed (the database was not kept up-to-date in the EGPWS).

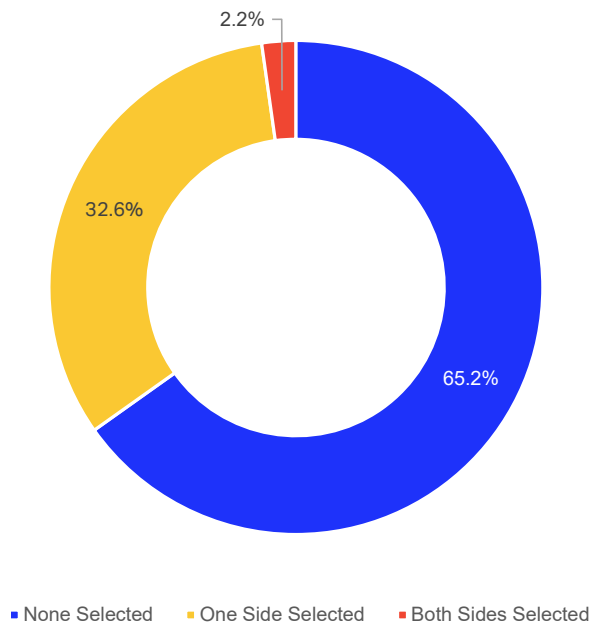
EGPWS Statistics

- **Terrain Awareness Display**
 - A terrain awareness display had not been selected prior to terrain awareness alerts in 65% of the cases.

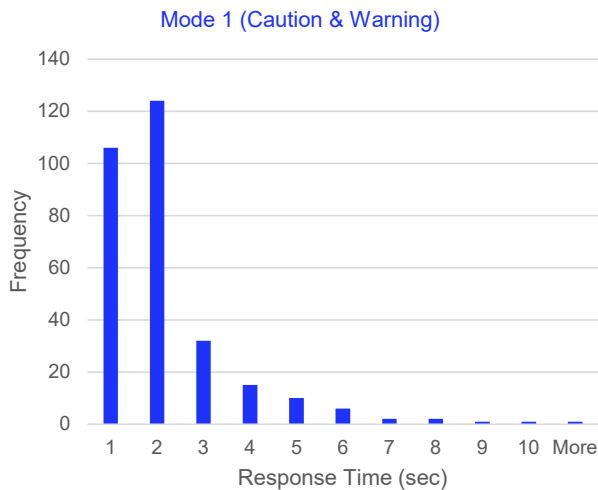
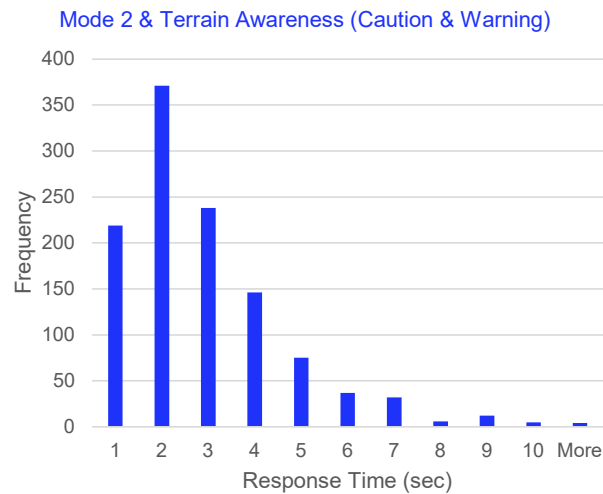
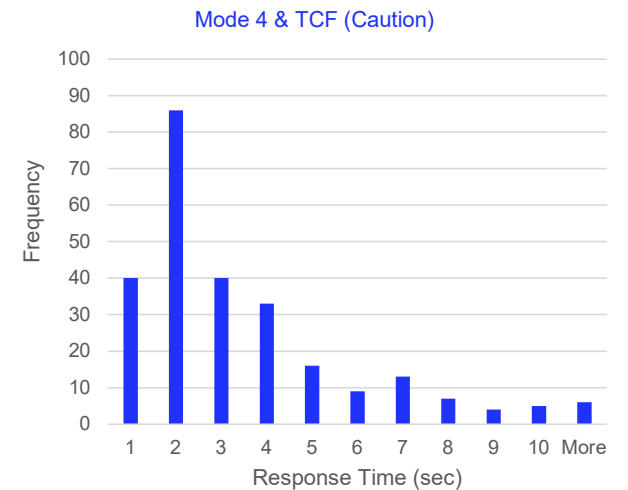
- **Response Time**

- Data collected suggests that pilot's response time is very similar regardless of EGPWS alert types or alert level (caution vs. warning).
